## General Information

| Make | Toyota | Model | Vios |
| YOM | 2023 | Mileage | 20,692 |
| Registration No. | NIP3689 | Chassis No. | PA1B18F33P4225350 |

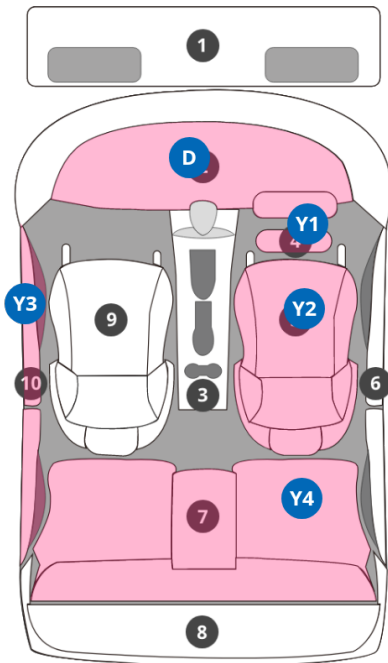
| Interior Evaluation : <span style="color: red;">C</span> | Exterior Evaluation : <span style="color: red;">A</span> |
| <p><b>Remarks</b></p> <p>Rear Seat - Grime - Large / (R) Front Seat - Grime - Small / Dashboard - Traces of Adhesive Tape - Yes / (L) Front Floor Mat - Grime - Minimal / (L) Front Trim - Grime - Medium</p> | <p><b>Remarks</b></p> <p>(R) Front Fender - Repair Traces - Yes / Rear Bumper, Lamps, Panels - Scratch - Small / (R) Front Door, Molding - Scratch - Small / (L) Front Door, Molding - Dent - Minimal / (L) Rear Door, Molding - Scratch - Minimal / (R) Front Fender, Molding - Dent - Minimal / (R) Rear Door, Molding - Dent - Minimal / Trunk Hood, Rear Gate - Scratch - Minimal / (L) Rear Fender, Molding - Scratch - Minimal</p> |
