## General Information

| Make | Toyota | Model | Wigo |
| YOM | 2023 | Mileage | 17,061 |
| Registration No. | EAF5059 | Chassis No. | MHKA4DF5FNJ072718 |

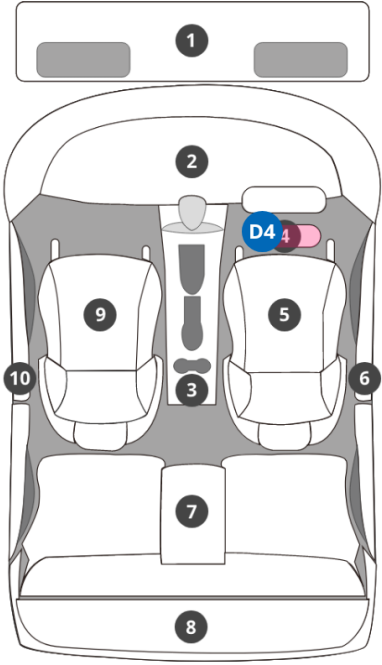
| Interior Evaluation : <span style="color: red;">C</span> | Exterior Evaluation : <span style="color: red;">E</span> |
| <b>Remarks</b><br>(L) Front Floor Mat - Worked - Large | <b>Remarks</b><br>(R) Rear Fender, Molding - Scratch & Dent - Large / Rear Bumper, Lamps, Panels - Scratch & Dent - Large / Roof Spoiler, Molding - Dent - Small / Bonnet, Headlight - Scratch - Small / (R) Front Fender, Molding - Scratch - Small / Front Bumper, Grille, Lamps - Scratch - Large / (L) Front Fender, Molding - Scratch - Small / (L) Rear Door, Molding - Scratch - Medium / (L) Step, In-panel, Side Spoiler - Scratch - Small / (L) Rear Fender, Molding - Scratch - Small / Trunk Hood, Rear Gate - Scratch - Medium |

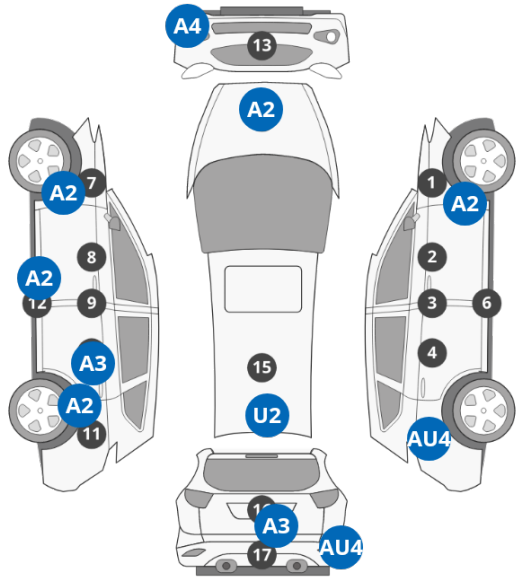
| Inspector Notes |
|---|
| tail light cracked/ no tools and jack/ with spare tire and LTO plate/ with warranty booklet/ |
