## General Information

| Make | Toyota | Model | Wigo |
| YOM | 2021 | Mileage | 52,854 |
| Registration No. | NEP3362 | Chassis No. | MHKA4DF5FLJ049598 |

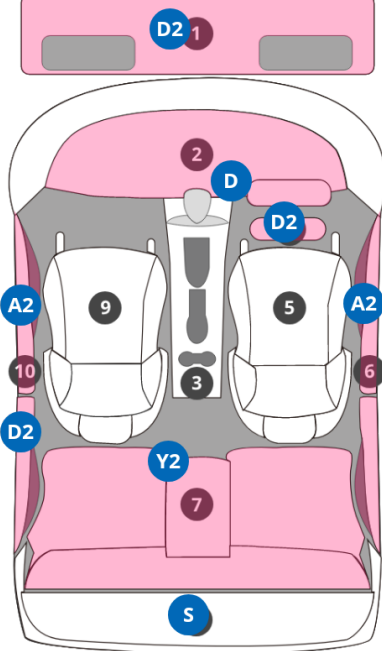
| Interior Evaluation : <b>C</b> | Exterior Evaluation : <b>E</b> |
| <p><b>Remarks</b></p> <p>Rear Seat - Grime - Small / (R) Front Trim - Cut, Crack - Small / (L) Rear Trim - Crinkle - Small / (L) Front Trim - Cut, Crack - Small / Overall Interior - Worn as per age - Yes / (L) Front Floor Mat - Worked - Small / Overall Interior - Smell - Yes / Ceiling - Crinkle - Small / Dashboard - Traces of Adhesive Tape - Yes</p> | <p><b>Remarks</b></p> <p>Trunk Hood, Rear Gate - Repair Traces - Yes / Rear End Panel - Replaced - Yes / (R) Rear Fender - Repair Traces - Yes / (R) Front Fender, Molding - Scratch &amp; Dent - Small / (R) Mirror - Scratch - Small / (R) Step, In-panel, Side Spoiler - Repair mark - Yes / (R) Front Door, Molding - Scratch - Small / (R) Rear Fender, Molding - Scratch &amp; Dent - Large / (R) Rear Door, Molding - Scratch - Small / Medium / Rear Bumper, Lamps, Panels - Repair mark - Yes / Rear Bumper, Lamps, Panels - Scratch - Large / Trunk Hood, Rear Gate - Scratch &amp; Dent - Small / (L) Rear Fender, Molding - Scratch - Small / (L) Rear Door, Molding - Scratch - Small / (L) Step, In-panel, Side Spoiler - Repair mark - Yes / (L) Front Door, Molding - Scratch &amp; Dent - Small / (L) Mirror - Scratch - Medium / (L) Front Fender, Molding - Scratch - Medium / Front Bumper, Grille, Lamps - Repair mark - Yes / Front Bumper, Grille, Lamps - Scratch &amp; Dent - Medium / Bonnet, Headlight - Scratch - Small / Roof - Scratch &amp; Dent - Medium</p> |
