## General Information

| Make | Toyota | Model | Vios |
| Registration No. | CAZ8993 | Chassis No. | PA1B18F39P4233162 |

## Body / Panel Condition

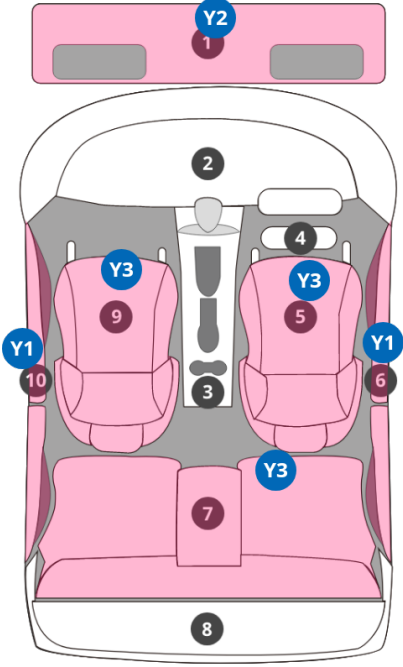
| Interior Evaluation : <b>B</b> | Exterior Evaluation : <b>C</b> |
|---|---|
| <p><b>Remarks</b><br/>(R) Front Seat - Grime - Medium / (L) Front Seat - Grime - Medium / Rear Seat - Grime - Medium / (R) Front Trim - Grime - Minimal / (L) Front Trim - Grime - Minimal / Ceiling - Grime - Small</p> | <p><b>Remarks</b><br/>(R) Mirror - Scratch - Small / (R) Front Door, Molding - Scratch &amp; Dent - Large / (R) Rear Door, Molding - Scratch - Small / Rear Bumper, Lamps, Panels - Scratch - Large / Trunk Hood, Rear Gate - Scratch &amp; Dent - Small / (L) Rear Door, Molding - Scratch - Small / (L) Mirror - Scratch - Minimal / (L) Front Door, Molding - Scratch - Minimal / Member (Bolted) - Dent - Yes / Front Bumper, Grille, Lamps - Scratch &amp; Dent - Medium</p> |
