## General Information

| Make | Toyota | Model | Vios |
| Registration No. | NIH1396 | Chassis No. | PA1B18F32N4199501 |

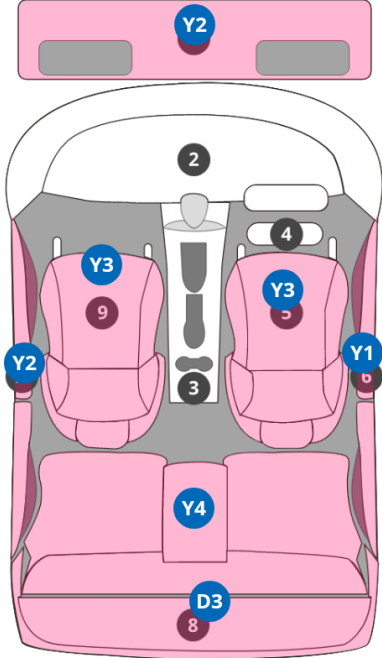
| Interior Evaluation : <span style="color: red; font-weight: bold;">C</span> | Exterior Evaluation : <span style="color: red; font-weight: bold;">C</span> |
| <p><b>Remarks</b></p> <p>Rear Seat - Grime - Large / (L) Front Trim - Grime - Small / (L) Front Seat - Grime - Medium / Trunk Room - Loose, Deformed - Medium / (R) Front Seat - Grime - Medium / (R) Front Trim - Grime - Minimal / Ceiling - Grime - Small</p> | <p><b>Remarks</b></p> <p>(L) Front Fender - Repair Traces - Yes / (L) Front Door - Repair Traces - Yes / (L) Step - Repair Traces - Yes / (L) Rear Door - Repair Traces - Yes / (L) Rear Fender - Repair Traces - Yes / (L) Step, In-panel, Side Spoiler - Scratch &amp; Dent - Medium / Front Bumper, Grille, Lamps - Scratch - Medium / (R) Front Door, Molding - Scratch - Small / (R) Rear Door, Molding - Scratch - Small / Rear Bumper, Lamps, Panels - Scratch &amp; Dent - Large / (L) Front Door, Molding - Repair mark - Yes / (L) Front Fender, Molding - Repair mark - Yes / Roof - Scratch - Minimal / (L) Rear Fender, Molding - Scratch - Small / (L) Rear Door, Molding - Scratch - Small</p> |
