## General Information

| Make | Toyota | Model | Vios |
| Registration No. | NHR8509 | Chassis No. | PA1B18F35P4231232 |

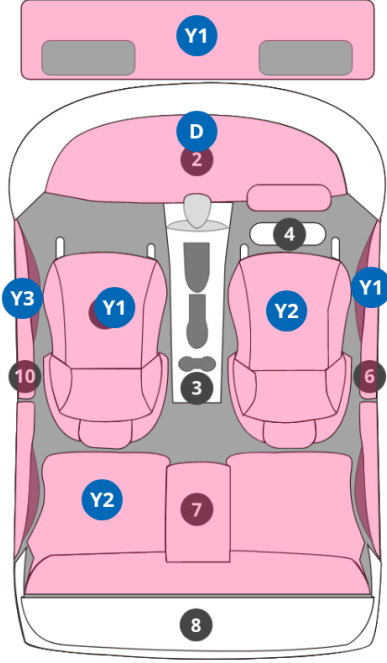
| <b>Interior Evaluation :</b> <b>B</b> | <b>Exterior Evaluation :</b> <b>C</b> |
| <b>Remarks</b><br>Dashboard - Traces of Adhesive Tape - Yes / (R) Front Seat - Grime - Small / Rear Seat - Grime - Small / (L) Front Seat - Grime - Minimal / (L) Front Trim - Grime - Medium / Ceiling - Grime - Minimal / (R) Front Trim - Grime - Minimal | <b>Remarks</b><br>Rear Bumper, Lamps, Panels - Scratch - Medium / (L) Rear Door, Molding - Scratch - Minimal / Front Bumper, Grille, Lamps - Scratch & Dent - Large / (R) Mirror - Scratch - Minimal / (R) Front Door, Molding - Scratch - Medium / (R) Rear Door, Molding - Dent - Medium / (R) Rear Fender, Molding - Scratch - Minimal / (L) Rear Fender, Molding - Scratch - Minimal / (L) Front Fender, Molding - Scratch - Minimal |
