## General Information

| Make | Toyota | Model | Vios |
| YOM | 2024 | Mileage | 22,682 |
| Registration No. | NHR7846 | Chassis No. | PA1B18F34P4231447 |

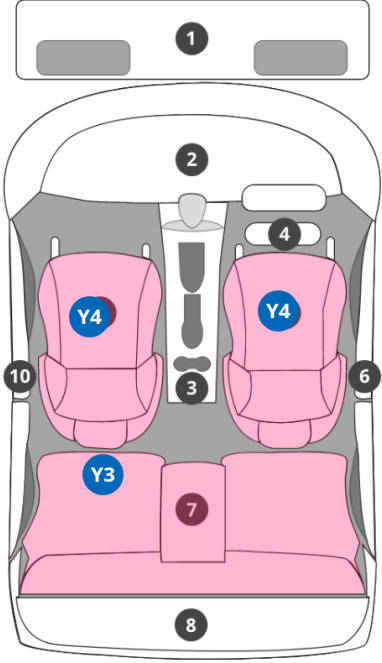
| Interior Evaluation : <b>C</b> | Exterior Evaluation : <b>E</b> |
|---|---|
| <p><b>Remarks</b><br/>(L) Front Seat - Grime - Large / (R) Front Seat - Grime - Large / Rear Seat - Grime - Medium</p> | <p><b>Remarks</b><br/>(R) Front Fender - Repair Traces - Yes / Rear Bumper, Lamps, Panels - Scratch - Large / (R) Rear Fender, Molding - Scratch - Large / (R) Rear Door, Molding - Scratch - Large / (R) Front Door, Molding - Scratch &amp; Dent - Large / Front Bumper, Grille, Lamps - Repair mark - Yes / (R) Front Fender, Molding - Repair mark - Yes / Front Bumper, Grille, Lamps - Dent - Large / Member (Bolted) - Dent - Yes / Bonnet, Headlight - Scratch - Minimal / (L) Front Door, Molding - Scratch - Medium / (L) Rear Door, Molding - Scratch - Medium / Trunk Hood, Rear Gate - Scratch - Medium</p> |
