## General Information

| Make | Toyota | Model | Vios |
| YOM | 2023 | Mileage | 13,383 |
| Registration No. | BAF4678 | Chassis No. | PA1B18F31P4225251 |

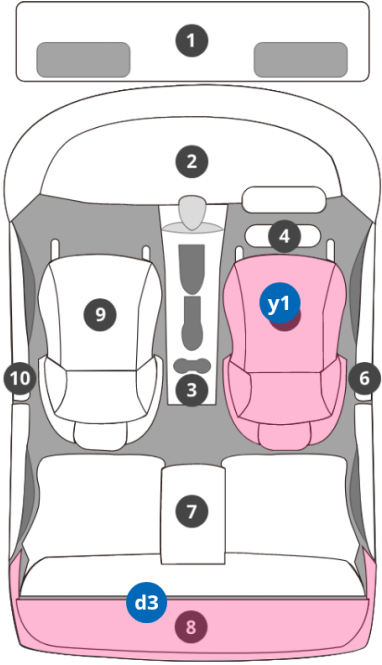
| Interior Evaluation : <b>B</b> | Exterior Evaluation : <b>B</b> |
| <b>Remarks</b><br>(R) Front Seat - Grime - Minimal / Trunk Room - Loose, Deformed, Grime - Medium | <b>Remarks</b><br>Bonnet, Headlight - Scratch - Small / Front Bumper, Grille, Lamps - Scratch - Minimal / (L) Front Door, Molding - Scratch - Small / (L) Rear Door, Molding - Scratch - Minimal / (L) Rear Fender, Molding - Scratch - Small / Trunk Hood, Rear Gate - Scratch - Small / (R) Rear Fender, Molding - Scratch - Small / (R) Front Door, Molding - Scratch - Small / (R) Mirror - Scratch - Minimal |

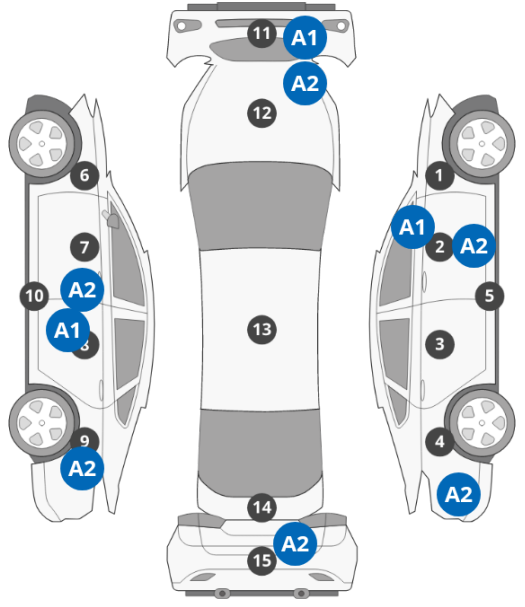
| Inspector Notes |
|---|
| more light scratches around the exterior. |
