## General Information

| Make | Toyota | Model | Vios |
| Registration No. | NHM1792 | Chassis No. | PA1B18F3XP4234109 |

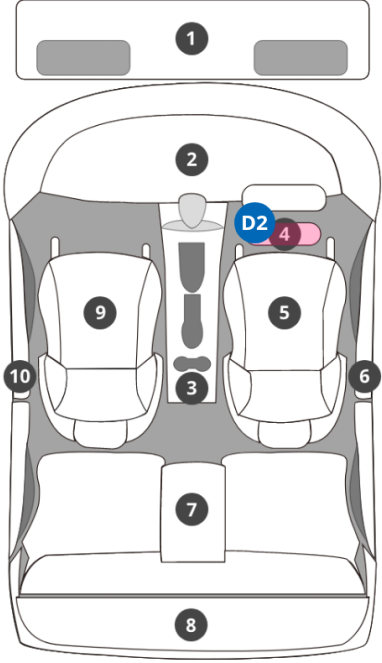
| <b>Interior Evaluation :</b> <span style="color: red; font-weight: bold;">A</span> | <b>Exterior Evaluation :</b> <span style="color: red; font-weight: bold;">D</span> |
| <b>Remarks</b><br>(L) Front Floor Mat - Worked - Small | <b>Remarks</b><br>(L) Front Door, Molding - Scratch & Dent - Medium / (L) Rear Door, Molding - Scratch & Dent - Medium / (L) Front Fender, Molding - Scratch - Large / Front Bumper, Grille, Lamps - Scratch & Dent - Medium / (R) Rear Door, Molding - Dent - Small / (R) Front Door, Molding - Dent - Small / Rear Bumper, Lamps, Panels - Scratch - Large / (L) Rear Fender, Molding - Scratch - Minimal / (L) Front Wheel, Cover - Scratch, Corrosion - Small / (L) Rear Wheel, Cover - Scratch, Corrosion - Small / (R) Front Wheel, Cover - Scratch, Corrosion - Small / (R) Rear Wheel, Cover - Scratch, Corrosion - Small / (R) Rear Fender, Molding - Scratch - Small |
