## General Information

| Make | Toyota | Model | Vios |
| YOM | 2024 | Mileage | 27,530 |
| Registration No. | NFR3028 | Chassis No. | PA1B18F36R4247572 |

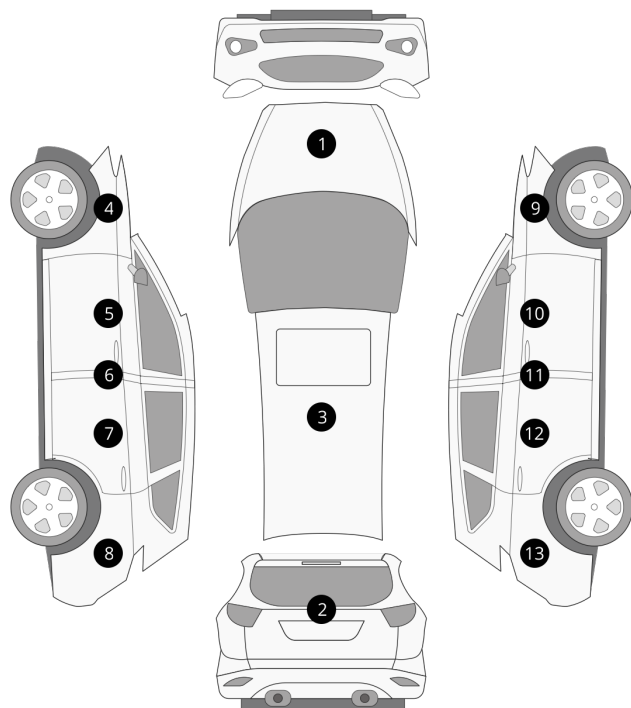
## Body / Panel Condition

| # | Area | Thickness(um) | | | |
|---|---|---|---|---|---|
| 4 | Left Front Fender | 198.6 | 198 | 245 | 153 |

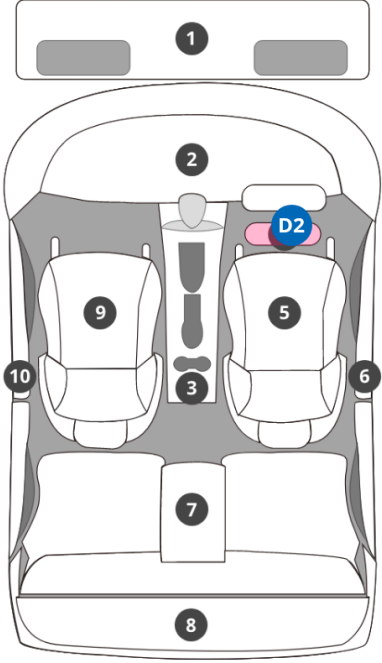
| <b>Interior Evaluation :</b> <span style="color: red; font-weight: bold;">A</span> | <b>Exterior Evaluation :</b> <span style="color: red; font-weight: bold;">C</span> |
| <b>Remarks</b><br>(L) Front Floor Mat - Worked - Small | <b>Remarks</b><br>(L) Front Fender - Repair Traces - Yes / (R) Mirror - Scratch - Minimal / (R) Front Door, Molding - Scratch - Small / (R) Rear Fender, Molding - Repair mark - Yes / (R) Rear Fender, Molding - Scratch - Medium / Rear Bumper, Lamps, Panels - Repair mark - Yes / Roof - Repair mark - Yes / Rear Bumper, Lamps, Panels - Scratch - Small / Trunk Hood, Rear Gate - Scratch - Small / (L) Rear Fender, Molding - Scratch - Small / (L) Mirror - Scratch - Minimal / Front Bumper, Grille, Lamps - Scratch - Medium / Roof - Scratch & Dent - Medium |
