## General Information

| Make | Toyota | Model | Vios |
| Registration No. | DBN7260 | Chassis No. | PA1B18F3XP4234675 |

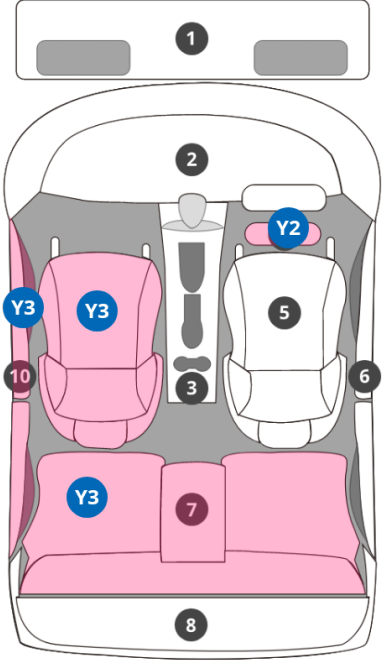
| Interior Evaluation : <b>B</b> | Exterior Evaluation : <b>B</b> |
|---|---|
| <b>Remarks</b><br>Rear Seat - Grime - Medium / (L) Front Seat - Grime - Medium / (L) Front Floor Mat - Grime - Small / (L) Front Trim - Grime - Medium | <b>Remarks</b><br>(L) Front Fender - Repair Traces - Yes / (R) Front Fender, Molding - Dent - Minimal / Rear Bumper, Lamps, Panels - Scratch & Dent - Medium / Trunk Hood, Rear Gate - Dent - Minimal / (L) Rear Fender, Molding - Scratch - Small / (L) Step, In-panel, Side Spoiler - Scratch & Dent - Medium / (L) Rear Door, Molding - Scratch - Minimal / (R) Rear Fender, Molding - Scratch - Minimal |
