## General Information

Date & Time: 04, Jun, 2025 13:46

<b>Make</b>	Toyota	<b>Model</b>	Raize
<b>YOM</b>	2024	<b>Odo Meter Reading</b>	28,943
<b>Registration No.</b>	YAB5578	<b>Chassis No.</b>	MHKAB1BA9PJ061903
<b>CC</b>	1.2	<b>Transmission</b>	M/T
<b>Fuel Type</b>	Gas	<b>Type of Body</b>	SUV
<b>Colour</b>	Silver

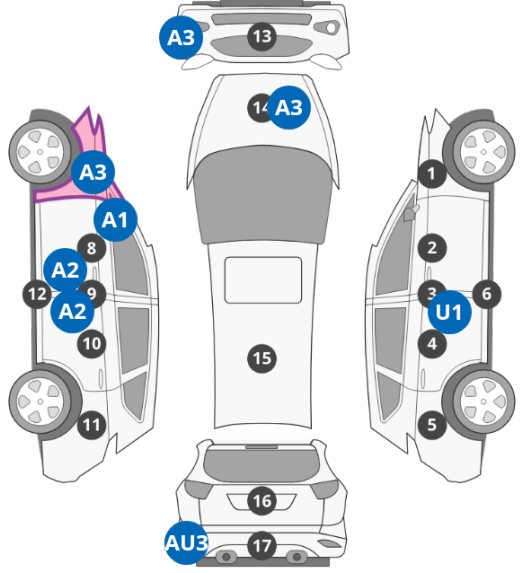
<p><b>A</b> : Scratch <b>AU</b> : Scratch &amp; Dent <b>B</b> : Modified <b>C</b> : Corrosion <b>G</b> : Stone chip <b>P</b> : Faded <b>S</b> : Rust <b>SC</b> : Rust &amp; Corrosion <b>U</b> : Dent <b>X</b> : Defective <b>Y</b> : Crack, Gap</p>
<p><b>Remarks</b> Rear Seat - Grime - Medium / (R) Front Seat - Grime - Medium / (L) Front Floor Mat - Worked - Small / Sunvisor, Sunglass Holder - Grime - Small / Ceiling - Grime - Minimal</p>	<p><b>Remarks</b> (R) Front Door - Repair Traces - Yes / (R) Rear Door, Molding - Dent - Minimal / Rear Bumper, Lamps, Panels - Scratch &amp; Dent - Medium / (L) Front Fender, Molding - Repair mark - Yes / (L) Front Fender, Molding - Scratch - Medium / (L) Rear Door, Molding - Scratch - Small / (L) Front Door, Molding - Scratch - Small / (L) Mirror - Scratch - Minimal / Front Bumper, Grille, Lamps - Scratch - Medium / Bonnet, Headlight - Scratch - Medium</p>
