## General Information

| Make | Toyota | Model | Vios |
| YOM | 2022 | Mileage | 67,463 |
| Registration No. | EAE7803 | Chassis No. | PA1B18F39M4166462 |

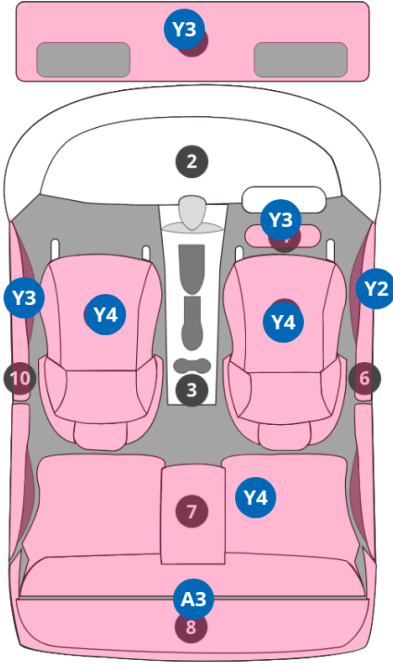
| Interior Evaluation : <b>D</b> | Exterior Evaluation : <b>E</b> |
|---|---|
| <b>Remarks</b><br>(R) Front Seat - Grime - Large / Rear Seat - Grime - Large / Trunk Room - Worn, Scratch, Cut, Crack - Medium / (L) Front Seat - Grime - Large / (L) Front Floor Mat - Grime - Medium / Ceiling - Grime - Medium / (L) Front Trim - Grime - Medium | <b>Remarks</b><br>Trunk Hood, Rear Gate - Repair Traces - Yes / Trunk Hood, Rear Gate - Scratch & Dent - Large / Rear Bumper, Lamps, Panels - Scratch - Large / (R) Step, In-panel, Side Spoiler - Dent - Small / (R) Rear Fender, Molding - Crack, Gap - Medium / (R) Front Door, Molding - Scratch & Dent - Small / Front Bumper, Grille, Lamps - Scratch - Medium / (L) Front Door, Molding - Scratch - Medium / (L) Rear Door, Molding - Scratch - Medium / (L) Step, In-panel, Side Spoiler - Scratch & Dent - Medium / (L) Rear Fender, Molding - Dent - Minimal / Roof - Dent - Minimal / (R) Front Fender, Molding - Dent - Minimal |
