## General Information

| Make | Toyota | Model | Vios |
| Registration No. | DAZ2436 | Chassis No. | PA1B18F32K4107407 |

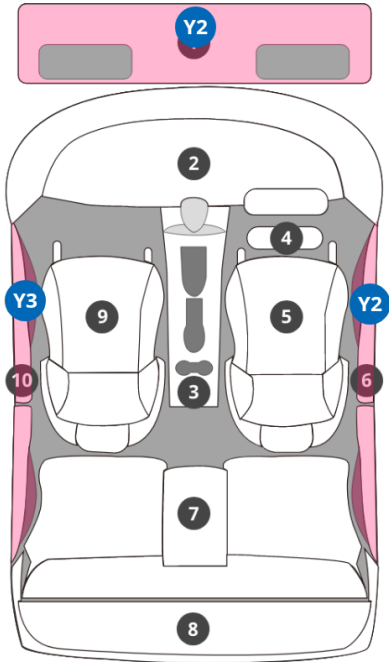
| Interior Evaluation : <span style="color: red; font-weight: bold;">B</span> | | Exterior Evaluation : <span style="color: red; font-weight: bold;">C</span> | |
| <p><b>Remarks</b></p> <p>(L) Front Trim - Grime - Medium / (R) Front Trim - Grime - Small / Ceiling - Grime - Small</p> | | <p><b>Remarks</b></p> <p>Member (Bolted) - Dent - Yes / (R) Rear Fender, Molding - Dent - Small / (R) Rear Door, Molding - Scratch &amp; Dent - Large / (R) Front Door, Molding - Scratch &amp; Dent - Small / Rear Bumper, Lamps, Panels - Scratch &amp; Dent - Medium / Trunk Hood, Rear Gate - Dent - Small / (L) Rear Fender, Molding - Scratch &amp; Dent - Small / (L) Step, In-panel, Side Spoiler - Scratch &amp; Dent - Small / (L) Front Door, Molding - Dent - Minimal / Front Bumper, Grille, Lamps - Scratch - Medium / (R) Front Fender, Molding - Crack, Gap - Medium</p> | |
