General Information

Make	Ford	Model	Everest
YOM	2018	Mileage	55,819
Registration No.	CAK6006	Chassis No.	MNCAXXMAWAJY02175
CC	2.2	Transmission	A/T
Fuel Type	Diesel	Type of Body	SUV
Colour	Red

Body / Panel Condition

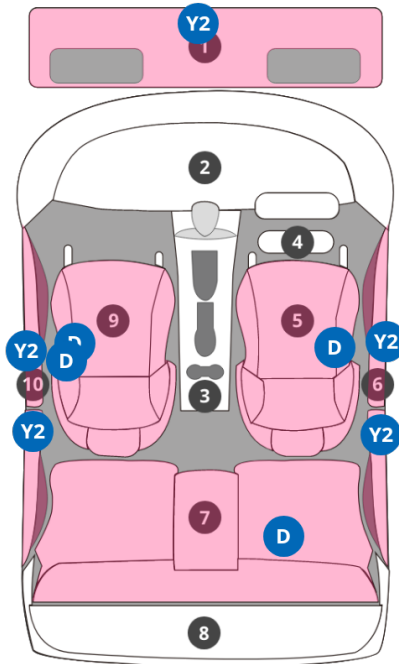
Interior Evaluation : C	Exterior Evaluation : C
<div style="text-align: center;">

</div> <p>a : Cut, Fray d : Loose, Deformed k : Animal Hair s : Smell t : Cigarette Burns x : Defective y : Stain</p>	<div style="text-align: center;">
