## General Information

| Make | Mitsubishi | Model | Xpander |
| Registration No. | NEF5610 | Chassis No. | MK2XRNC1WKN078285 |

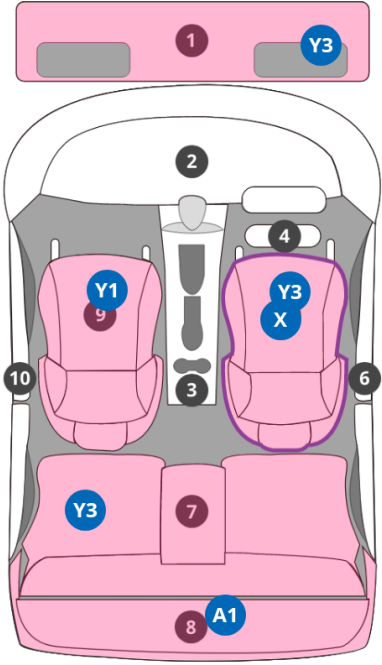
| Interior Evaluation : <b>B</b> | Exterior Evaluation : <b>E</b> |
|---|---|
| <b>Remarks</b><br>(R) Front Seat Head Rest - Missing - Yes / Ceiling - Grime - Medium / (L) Front Seat - Grime - Minimal / Rear Seat - Grime - Medium / (R) Front Seat - Grime - Medium / Trunk Room - Worn, Scratch, Cut, Crack - Minimal | <b>Remarks</b><br>(L) Rear Door - Repair Traces - Yes / (L) Rear Fender - Repair Traces - Yes / (L) Rear Door, Molding - Repair mark - Yes / (L) Rear Fender, Molding - Repair mark - Yes / Trunk Hood, Rear Gate - Scratch & Dent - Large / (R) Rear Door, Molding - Scratch & Dent - Large / (R) Rear Fender, Molding - Scratch & Dent - Large / (R) Front Door, Molding - Scratch & Dent - Large / Front Bumper, Grille, Lamps - Crack, Gap - Large / Bonnet, Headlight - Rust, Corrosion - Minimal / (L) Mirror - Scratch, Peeled - Minimal / (L) Rear Fender, Molding - Scratch - Small / (L) Rear Door, Molding - Scratch - Small / Roof - Scratch - Minimal / (L) Front Door, Molding - Scratch - Small / (L) Front Fender, Molding - Crack, Gap - Medium |
