## General Information

Date & Time: 02, May, 2025 08:57

<b>Make</b>	Toyota	<b>Model</b>	Vios
<b>YOM</b>	2023	<b>Mileage</b>	28,521
<b>Registration No.</b>	NFP5709	<b>Chassis No.</b>	PA1B18F35N4192896
<b>CC</b>	1.3	<b>Transmission</b>	CVT
<b>Fuel Type</b>	Gas	<b>Type of Body</b>	Sedan
<b>Colour</b>	Red Mica Metallic

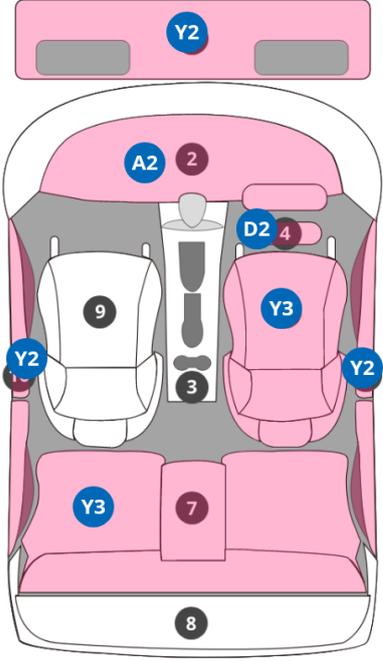
<b>Interior Evaluation :</b> <span style="float: right;"><b>B</b></span>	<b>Exterior Evaluation :</b> <span style="float: right;"><b>E</b></span>

<p><b>a</b> : Cut, Fray <b>d</b> : Loose, Deformed <b>k</b> : Animal Hair <b>s</b> : Smell <b>t</b> : Cigarette Burns <b>x</b> : Defective <b>y</b> : Stain</p>

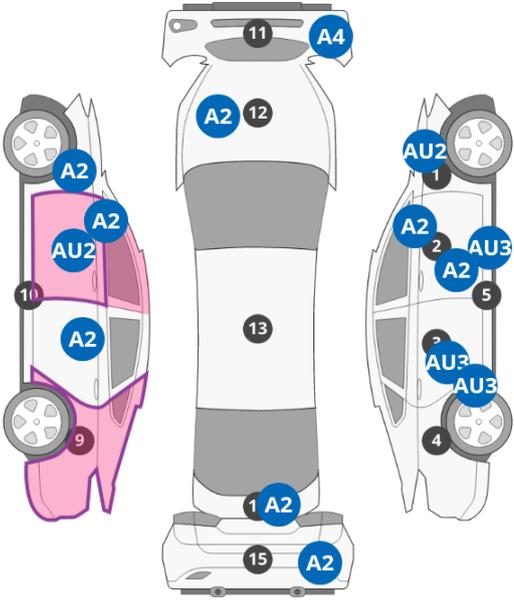
<p><b>A</b> : Scratch <b>AU</b> : Scratch &amp; Dent <b>B</b> : Modified <b>C</b> : Corrosion <b>G</b> : Stone chip <b>P</b> : Faded <b>S</b> : Rust <b>SC</b> : Rust &amp; Corrosion <b>U</b> : Dent <b>X</b> : Defective <b>Y</b> : Crack, Gap</p>
<p><b>Remarks</b> Ceiling - Grime - Small / (R) Front Trim - Grime - Small / (R) Front Seat - Grime - Medium / Rear Seat - Grime - Medium / (L) Front Trim - Grime - Small / (L) Front Floor Mat - Worked - Small / Dashboard - Worn, Scratch, Cut, Crack - Small</p>	<p><b>Remarks</b> (R) Rear Door, Molding - Scratch &amp; Dent - Medium / (R) Rear Fender, Molding - Scratch &amp; Dent - Medium / Front Bumper, Grille, Lamps - Scratch - Large / (R) Front Fender, Molding - Scratch &amp; Dent - Small / (R) Step, In-panel, Side Spoiler - Scratch &amp; Dent - Medium / (R) Front Door, Molding - Scratch - Small / (L) Front Door, Molding - Scratch &amp; Dent - Small / (L) Mirror - Scratch - Small / (L) Front Door, Molding - Repair mark - Yes / (L) Front Fender, Molding - Scratch - Small / (L) Rear Door, Molding - Scratch - Small / Rear Bumper, Lamps, Panels - Scratch - Small / Trunk Hood, Rear Gate - Scratch - Small / Bonnet, Headlight - Scratch - Small / (R) Mirror - Scratch - Small / (L) Rear Fender, Molding - Repair mark - Yes</p>
