General Information

Make	Toyota	Model	Innova
YOM	2020	Mileage	67,378
Registration No.	CAU2838	Chassis No.	PA2JA8EM5K0076117
CC	2.8	Transmission	A/T
Fuel Type	Diesel	Type of Body	Wagon
Colour	Silver

Body / Panel Condition

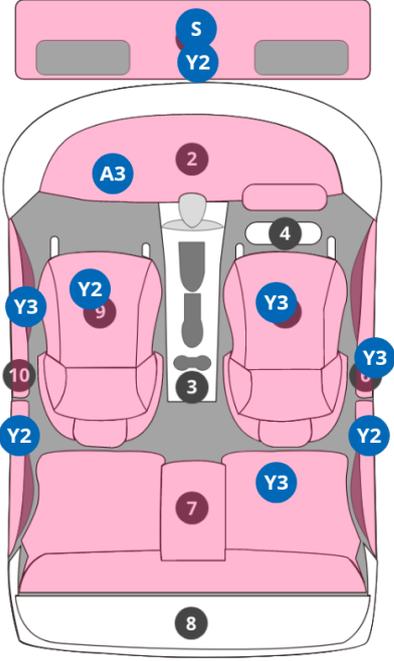
Interior Evaluation :	C	Exterior Evaluation :	E

<p>a : Cut, Fray d : Loose, Deformed k : Animal Hair s : Smell t : Cigarette Burns x : Defective y : Stain</p>		<p>A : Scratch AU : Scratch & Dent B : Modified C : Corrosion G : Stone chip P : Faded S : Rust SC : Rust & Corrosion U : Dent X : Defective Y : Crack, Gap</p>	
<p>Remarks Overall Interior - Smell - Yes / Ceiling - Grime - Small / (R) Front Seat - Grime - Medium / Dashboard - Worn, Scratch, Cut, Crack - Medium / (R) Front Trim - Grime - Medium / (R) Rear Trim - Grime - Small / Rear Seat - Grime - Medium / (L) Rear Trim - Grime - Small / (L) Front Trim - Grime - Medium / (L) Front Seat - Grime - Small</p>		<p>Remarks (R) Front Door - Repair Traces - Yes / (R) Step - Repair Traces - Yes / (L) Rear Fender - Repair Traces - Yes / (R) Rear Door - Repair Traces - Yes / Roof - Repair Traces - Yes / (R) Mirror - Scratch - Medium / (R) Rear Fender, Molding - Scratch - Small / (R) Front Door, Molding - Repair mark - Yes / (R) Front Door, Molding - Scratch - Small / (R) Rear Door, Molding - Repair mark - Yes / (R) Rear Door, Molding - Scratch - Minimal / Trunk Hood, Rear Gate - Scratch & Dent - Medium / Rear Bumper, Lamps, Panels - Scratch - Medium / (L) Rear Fender, Molding - Scratch - Small / (L) Front Door, Molding - Scratch & Dent - Small / (L) Mirror - Scratch - Minimal / (L) Front Fender, Molding - Scratch - Small / Front Bumper, Grille, Lamps - Repair mark - Yes / Rear Bumper, Lamps, Panels - Repair mark - Yes / Front Bumper, Grille, Lamps - Scratch - Medium / (R) Front Fender, Molding - Repair mark - Yes</p>
