## General Information

Date & Time: 02, May, 2025 10:14

<b>Make</b>	Honda	<b>Model</b>	City
<b>YOM</b>	2021	<b>Mileage</b>	59,719
<b>Registration No.</b>	NGN3672	<b>Chassis No.</b>	MRHGN2620MT060145
<b>CC</b>	1.5	<b>Transmission</b>	A/T
<b>Fuel Type</b>	Gas	<b>Type of Body</b>	Sedan
<b>Colour</b>	White

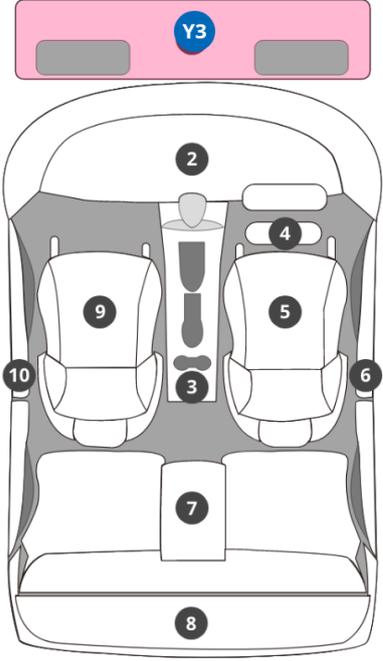
<b>Interior Evaluation :</b> <span style="float: right;"><b>B</b></span>	<b>Exterior Evaluation :</b> <span style="float: right;"><b>D</b></span>

<p><b>A</b> : Scratch <b>AU</b> : Scratch &amp; Dent <b>B</b> : Modified <b>C</b> : Corrosion <b>G</b> : Stone chip <b>P</b> : Faded <b>S</b> : Rust <b>SC</b> : Rust &amp; Corrosion <b>U</b> : Dent <b>X</b> : Defective <b>Y</b> : Crack, Gap</p>
<b>Remarks</b> Ceiling - Grime - Medium	<b>Remarks</b> (R) Front Door, Molding - Repair mark - Yes / (R) Front Door, Molding - Scratch & Dent - Small / (R) Rear Door, Molding - Scratch - Large / (R) Rear Fender, Molding - Scratch - Small / Rear Bumper, Lamps, Panels - Scratch - Medium / (L) Front Door, Molding - Scratch & Dent - Small / (L) Front Door, Molding - Repair mark - Yes / (L) Mirror - Scratch - Small / (L) Front Fender, Molding - Scratch - Small / (L) Rear Fender, Molding - Scratch - Small / (L) Rear Door, Molding - Scratch - Medium / Front Bumper, Grille, Lamps - Scratch & Dent - Medium / Bonnet, Headlight - Scratch & Dent - Small / (R) Front Fender, Molding - Scratch - Minimal
