General Information

Date & Time: 02, May, 2025 14:03

Make	Isuzu	Model	D-MAX
YOM	2019	Mileage	77,192
Registration No.	NBO8172	Chassis No.	PABTFR87DJ2000911
CC	1.9	Transmission	M/T
Fuel Type	Diesel	Type of Body	Pickup
Colour	White

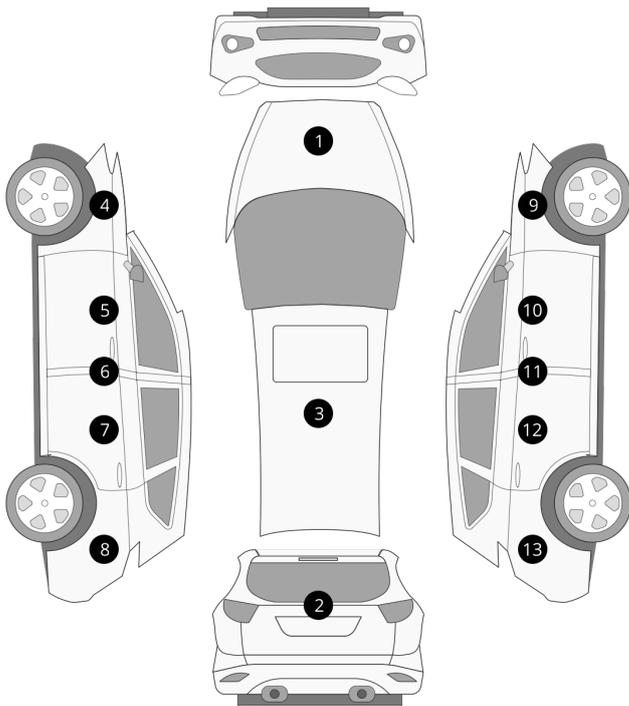
Body / Panel Condition

#	Area	Thickness(um)			
		Average	Value1	Value2	Value3/4
1	Bonnet	91.7	95	87	93
2	Boot Lid	99.9	91	102	107
3	Roof	90.7	78	91	105/89
4	Left Front Fender	86.5	86	86	88
5	Left Front Door	99.4	95	107	97
6	Center Panel Left				
7	Left Rear Door	106.7	124	98	98
8	Left Back Panel	143.3	164	108	158
9	Right Front Fender	89.1	92	90	86
10	Right Front Door	144.6	142	171	121
11	Center Panel Right				
12	Right Rear Door	135.3	123	133	150
13	Right Back Panel	135.6	112	162	133

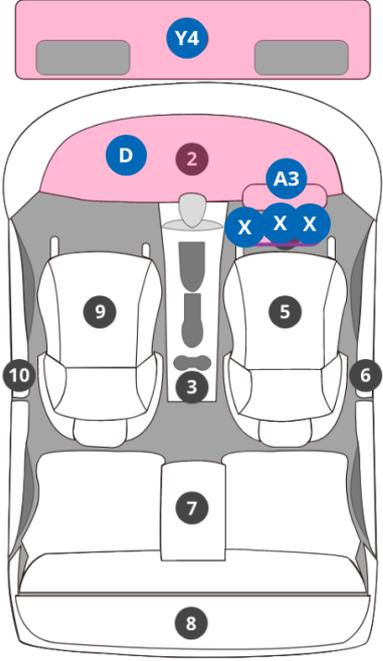
Interior Evaluation : C	Exterior Evaluation : E

<p>a : Cut, Fray d : Loose, Deformed k : Animal Hair s : Smell t : Cigarette Burns x : Defective y : Stain</p>

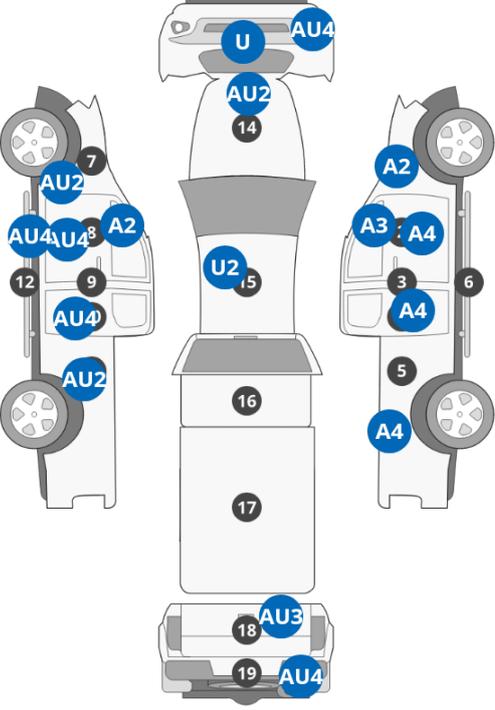
<p>A : Scratch AU : Scratch & Dent B : Modified C : Corrosion G : Stone chip P : Faded S : Rust SC : Rust & Corrosion U : Dent X : Defective Y : Crack, Gap</p>
<p>Remarks Ceiling - Grime - Large / (R) Front Floor Mat - Missing - Yes / Mat Other - Missing - Yes / (L) Front Floor Mat - Missing - Yes / Dashboard - Traces of Adhesive Tape - Yes / Steering Wheel - Worn, Peel, Crack - Medium</p>	<p>Remarks (R) Front Door - Repair Traces - Yes / (L) Rear Door, Molding - Scratch & Dent - Large / (L) Front Door, Molding - Scratch & Dent - Large / (L) Step, In-panel, Side Spoiler - Scratch & Dent - Large / (L) Front Fender, Molding - Scratch & Dent - Small / (L) Mirror - Scratch - Small / Front Bumper, Grille, Lamps - Scratch & Dent - Large / Bonnet, Headlight - Scratch & Dent - Small / (R) Mirror - Scratch - Medium / (R) Front Fender, Molding - Scratch - Small / (R) Front Door, Molding - Scratch - Large / (R) Rear Door, Molding - Scratch - Large / (R) Side Gate - Scratch - Large / Rear Bumper, Lamps, Panels - Scratch & Dent - Large / Rear Gate - Scratch & Dent - Medium / (L) Side Gate - Scratch & Dent - Small / Roof - Dent - Small / Member (Bolted) - Dent - Yes</p>
