General Information

Make	Mazda	Model	Mazda 2
YOM	2019	Mileage	50,336
Registration No.	NED9825	Chassis No.	MM7DJ2HAAKW406577
CC	1.5	Transmission	A/T
Fuel Type	Gas	Type of Body	Hatchback
Colour	Gray

Body / Panel Condition

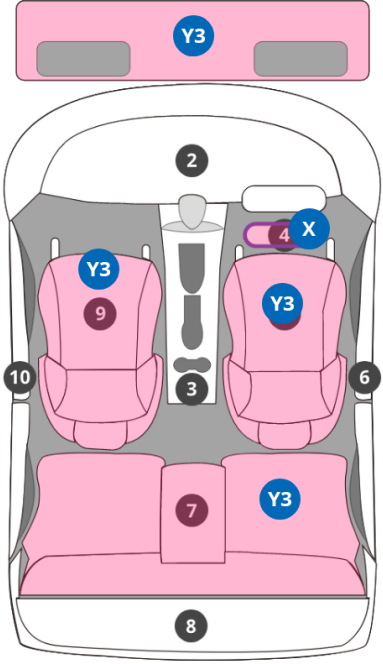
Interior Evaluation : B	Exterior Evaluation : C

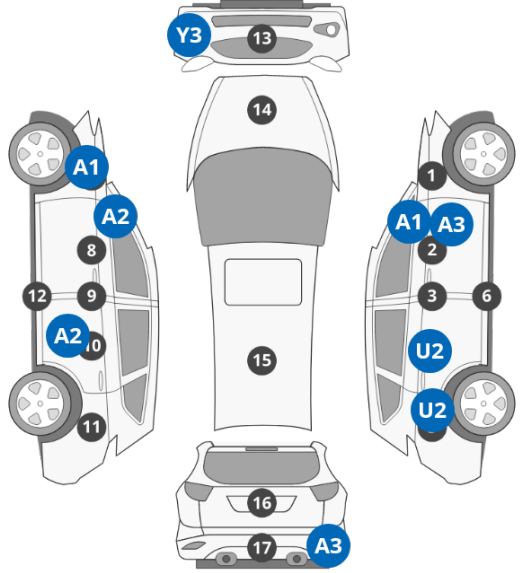
<p>A : Scratch AU : Scratch & Dent B : Modified C : Corrosion G : Stone chip P : Faded S : Rust SC : Rust & Corrosion U : Dent X : Defective Y : Crack, Gap</p>
<p>Remarks (R) Front Floor Mat - Missing - Yes / (R) Front Seat - Grime - Medium / Rear Seat - Grime - Medium / (L) Front Seat - Grime - Medium / Ceiling - Grime - Medium</p>	<p>Remarks (L) Front Fender - Repair Traces - Yes / (L) Mirror - Scratch - Small / (R) Mirror - Scratch - Minimal / (R) Front Door, Molding - Scratch - Medium / (R) Rear Fender, Molding - Dent - Small / (R) Rear Door, Molding - Dent - Small / Front Bumper, Grille, Lamps - Crack, Gap - Medium / (L) Front Fender, Molding - Scratch - Minimal / (L) Rear Door, Molding - Scratch - Small / Rear Bumper, Lamps, Panels - Scratch - Medium</p>
