## General Information

| Make | Toyota | Model | Vios |

## Body / Panel Condition

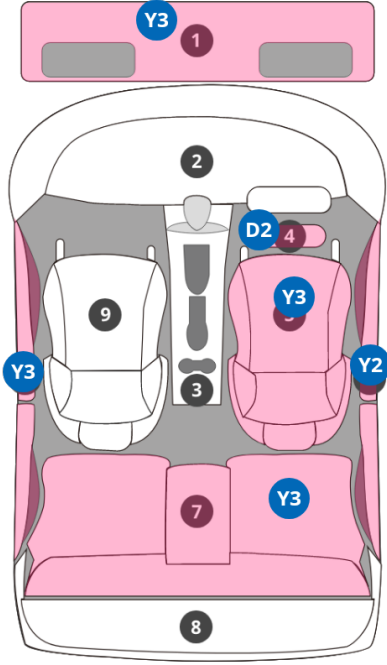
| Interior Evaluation : <span style="color: red;">C</span> | Exterior Evaluation : <span style="color: red;">D</span> |
| <b>Remarks</b><br>Ceiling - Grime - Medium / (R) Front Seat - Grime - Medium / (R) Front Trim - Grime - Small / Rear Seat - Grime - Medium / (L) Front Trim - Grime - Medium / (L) Front Floor Mat - Worked - Small | <b>Remarks</b><br>Front Bumper, Grille, Lamps - Scratch & Dent - Large / (R) Front Door, Molding - Scratch - Medium / Bonnet, Headlight - Crack, Gap - Large / (R) Rear Fender, Molding - Scratch - Medium / Rear Bumper, Lamps, Panels - Scratch - Large / (R) Mirror - Scratch - Small / Trunk Hood, Rear Gate - Scratch & Dent - Small / (L) Rear Fender, Molding - Repair mark - Yes / (L) Front Door, Molding - Scratch - Small / (L) Mirror - Scratch - Small |
