## General Information

Date & Time: 09, May, 2025 13:56

<b>Make</b>	Honda	<b>Model</b>	City
<b>YOM</b>	2018	<b>Mileage</b>	55,605
<b>Registration No.</b>	GAH9159	<b>Chassis No.</b>	PADGM6620JV412904
<b>CC</b>	1.5	<b>Transmission</b>	A/T
<b>Fuel Type</b>	Gas	<b>Type of Body</b>	Sedan
<b>Colour</b>	Gray

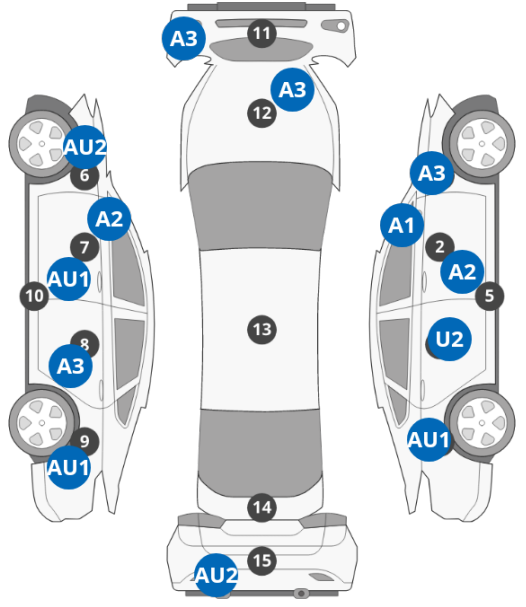
<p><b>A</b> : Scratch <b>AU</b> : Scratch &amp; Dent <b>B</b> : Modified <b>C</b> : Corrosion <b>G</b> : Stone chip <b>P</b> : Faded <b>S</b> : Rust <b>SC</b> : Rust &amp; Corrosion <b>U</b> : Dent <b>X</b> : Defective <b>Y</b> : Crack, Gap</p>
<p><b>Remarks</b>          Ceiling - Grime - Minimal / (R) Front Floor Mat - Grime - Medium / (L) Front Floor Mat - Missing - Yes / (L) Front Seat - Grime - Medium / Dashboard - Traces of Adhesive Tape - Yes</p>	<p><b>Remarks</b>          (R) Rear Fender, Molding - Scratch &amp; Dent - Minimal / (L) Front Door, Molding - Scratch &amp; Dent - Minimal / (L) Rear Door, Molding - Scratch - Medium / (L) Rear Fender, Molding - Scratch &amp; Dent - Minimal / Rear Bumper, Lamps, Panels - Scratch &amp; Dent - Small / (R) Front Door, Molding - Scratch - Small / (R) Mirror - Scratch - Minimal / (R) Rear Door, Molding - Dent - Small / (R) Front Fender, Molding - Scratch - Medium / Bonnet, Headlight - Scratch - Medium / (L) Mirror - Scratch - Small / (L) Front Fender, Molding - Scratch &amp; Dent - Small / Front Bumper, Grille, Lamps - Scratch - Medium</p>
