General Information

| Make | Toyota | Model | Vios |
| Registration No. | DBH7013 | Chassis No. | PA1B18F31P4210300 |

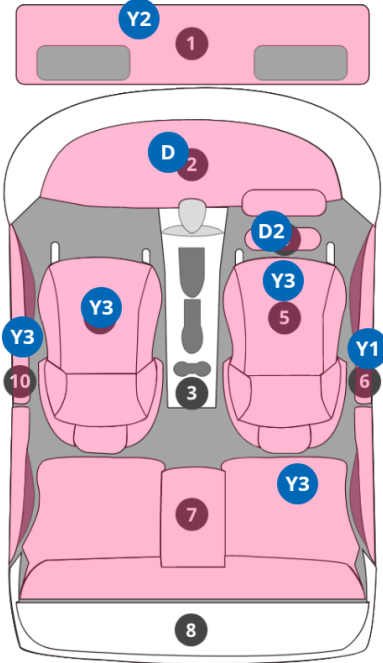
| Interior Evaluation : C | Exterior Evaluation : E |

| <p>Remarks Rear Seat - Grime - Medium / (R) Front Seat - Grime - Medium / (L) Front Seat - Grime - Medium / (R) Front Trim - Grime - Minimal / (L) Front Trim - Grime - Medium / (L) Front Floor Mat - Worked - Small / Dashboard - Traces of Adhesive Tape - Yes / Ceiling - Grime - Small</p> | <p>Remarks (L) Front Fender - Repair Traces - Yes / (R) Front Fender, Molding - Dent - Small / (R) Mirror - Scratch - Small / (R) Rear Fender, Molding - Scratch & Dent - Medium / (R) Front Door, Molding - Scratch - Medium / (R) Rear Door, Molding - Scratch - Small / Rear Bumper, Lamps, Panels - Scratch - Medium / Trunk Hood, Rear Gate - Scratch - Minimal / (L) Rear Fender, Molding - Dent - Medium / (L) Rear Door, Molding - Dent - Small / (L) Front Door, Molding - Scratch - Small / (L) Front Fender, Molding - Scratch & Dent - Large / Bonnet, Headlight - Repair mark - Yes / Front Bumper, Grille, Lamps - Repair mark - Yes / Member (Bolted) - Dent - Yes / Front Bumper, Grille, Lamps - Crack, Gap - Large / Bonnet, Headlight - Scratch - Medium</p> |
