## General Information

Date & Time: 03, Jun, 2025 13:15

<b>Make</b>	Toyota	<b>Model</b>	Vios
<b>YOM</b>	2023	<b>Odo Meter Reading</b>	93,264
<b>Registration No.</b>	NHI3935	<b>Chassis No.</b>	PA1B18F3XP4205564
<b>CC</b>	1.3	<b>Transmission</b>	CVT
<b>Fuel Type</b>	Gas	<b>Type of Body</b>	Sedan
<b>Colour</b>	Green

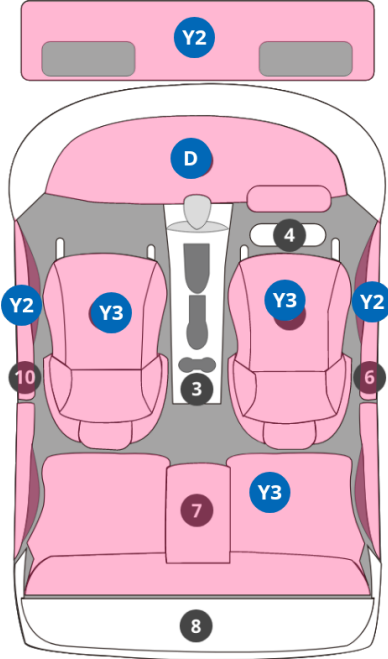
<b>Interior Evaluation :</b> <span style="float: right; color: red; font-weight: bold;">C</span>	<b>Exterior Evaluation :</b> <span style="float: right; color: red; font-weight: bold;">E</span>

<p><b>a</b> : Cut, Fray <b>d</b> : Loose, Deformed <b>k</b> : Animal Hair <b>s</b> : Smell <b>t</b> : Cigarette Burns <b>x</b> : Defective <b>y</b> : Stain</p>

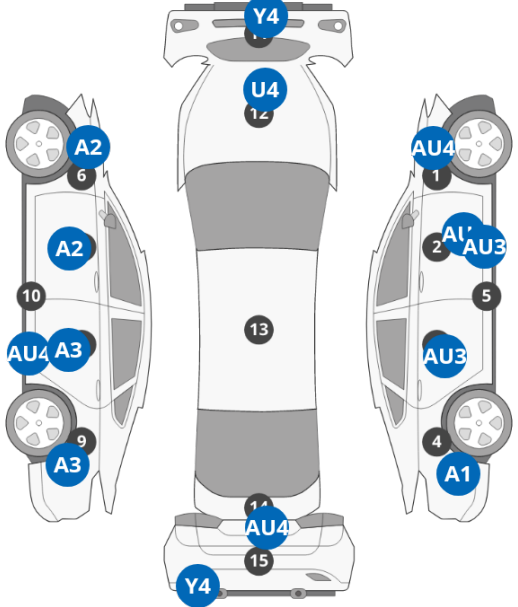
<p><b>A</b> : Scratch <b>AU</b> : Scratch &amp; Dent <b>B</b> : Modified <b>C</b> : Corrosion <b>G</b> : Stone chip <b>P</b> : Faded <b>S</b> : Rust <b>SC</b> : Rust &amp; Corrosion <b>U</b> : Dent <b>X</b> : Defective <b>Y</b> : Crack, Gap</p>
<p><b>Remarks</b> (L) Front Trim - Grime - Small / (L) Front Seat - Grime - Medium / (R) Front Seat - Grime - Medium / (R) Front Trim - Grime - Small / Rear Seat - Grime - Medium / Ceiling - Grime - Small / Dashboard - Traces of Adhesive Tape - Yes</p>	<p><b>Remarks</b> (L) Rear Fender - Repair Traces - Yes / Trunk Hood, Rear Gate - Scratch &amp; Dent - Large / Rear Bumper, Lamps, Panels - Crack, Gap - Large / (L) Rear Fender, Molding - Scratch - Medium / (L) Step, In-panel, Side Spoiler - Scratch &amp; Dent - Large / (L) Rear Door, Molding - Scratch - Medium / (L) Front Door, Molding - Scratch - Small / Front Bumper, Grille, Lamps - Crack, Gap - Large / Bonnet, Headlight - Dent - Large / (L) Front Fender, Molding - Scratch - Small / (R) Front Fender, Molding - Scratch &amp; Dent - Large / (R) Front Door, Molding - Scratch &amp; Dent - Large / (R) Step, In-panel, Side Spoiler - Scratch &amp; Dent - Medium / (R) Rear Door, Molding - Scratch &amp; Dent - Medium / (R) Rear Fender, Molding - Scratch - Minimal</p>
