## General Information

Date & Time: 03, Jun, 2025 08:45

<b>Make</b>	Toyota	<b>Model</b>	Vios
<b>YOM</b>	2024	<b>Odo Meter Reading</b>	8,627
<b>Registration No.</b>	NEY5323	<b>Chassis No.</b>	PA1B18F34R4256402
<b>CC</b>	1.3	<b>Transmission</b>	CVT
<b>Fuel Type</b>	Gas	<b>Type of Body</b>	Sedan
<b>Colour</b>	Red

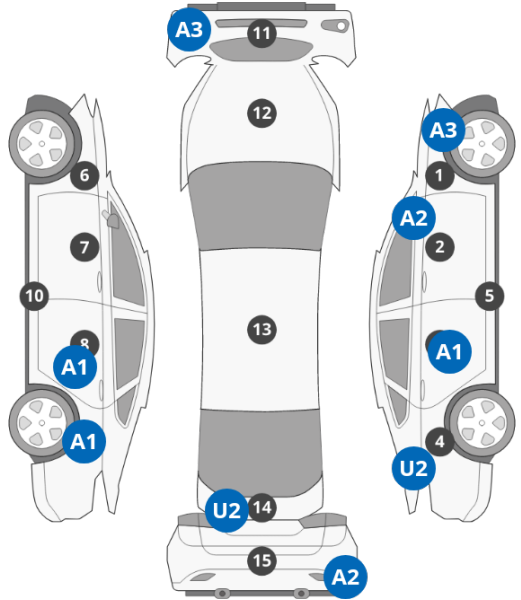
<p><b>A</b> : Scratch <b>AU</b> : Scratch &amp; Dent <b>B</b> : Modified <b>C</b> : Corrosion <b>G</b> : Stone chip <b>P</b> : Faded <b>S</b> : Rust <b>SC</b> : Rust &amp; Corrosion <b>U</b> : Dent <b>X</b> : Defective <b>Y</b> : Crack, Gap</p>
<p><b>Remarks</b> (L) Front Floor Mat - Worked - Large / (L) Front Trim - Grime - Minimal</p>	<p><b>Remarks</b> (R) Rear Fender - Repair Traces - Yes / (R) Rear Door - Repair Traces - Yes / (R) Front Fender, Molding - Scratch - Medium / (R) Mirror - Scratch - Small / (R) Rear Door, Molding - Scratch - Minimal / (R) Rear Fender, Molding - Dent - Small / Rear Bumper, Lamps, Panels - Scratch - Small / Trunk Hood, Rear Gate - Dent - Small / (L) Rear Fender, Molding - Scratch - Minimal / (L) Rear Door, Molding - Scratch - Minimal / Front Bumper, Grille, Lamps - Scratch - Medium</p>
