## General Information

| Make | Toyota | Model | Vios |
| YOM | 2023 | Mileage | 21,650 |
| Registration No. | DBB5967 | Chassis No. | PA1B18F35P4205746 |

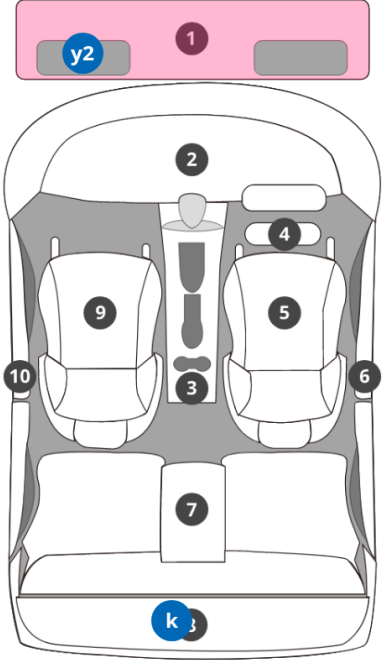
| <b>Remarks</b><br>Sunvisor, Sunglass Holder - Grime - Small / Overall Interior - Animal Hair - Yes | <b>Remarks</b><br>(R) Front Fender - Repair Traces - Yes / (L) Front Fender - Repair Traces - Yes / (L) Front Fender, Molding - Scratch - Small / (L) Front Door, Molding - Scratch - Minimal / (L) Rear Fender, Molding - Scratch - Small / Rear Bumper, Lamps, Panels - Scratch - Small / (R) Rear Fender, Molding - Scratch - Small / (R) Front Door, Molding - Scratch & Dent - Minimal / (R) Front Fender, Molding - Scratch - Small / Front Bumper, Grille, Lamps - Scratch - Minimal |

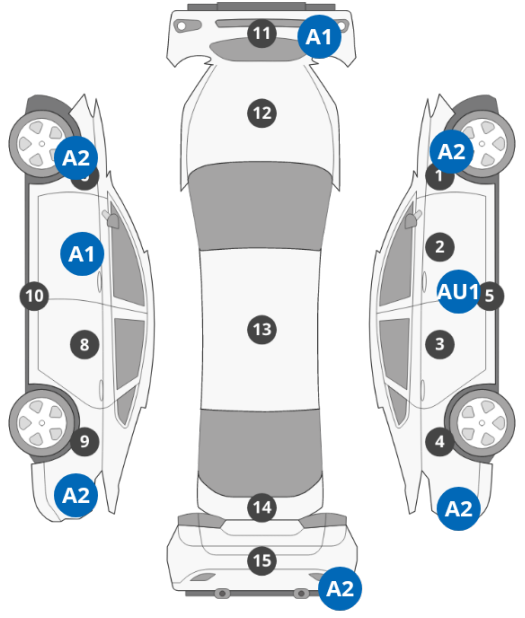
| more light scratches around the exterior. low washer fluid. |
