## General Information

<b>Make</b>	Nissan	<b>Model</b>	Terra
<b>YOM</b>	2019	<b>Mileage</b>	76,791
<b>Registration No.</b>	MAJ6024	<b>Chassis No.</b>	MNTJCAD23Z0008793
<b>CC</b>	2.5	<b>Transmission</b>	A/T
<b>Fuel Type</b>	Diesel	<b>Type of Body</b>	SUV
<b>Colour</b>	Brown

## Body / Panel Condition

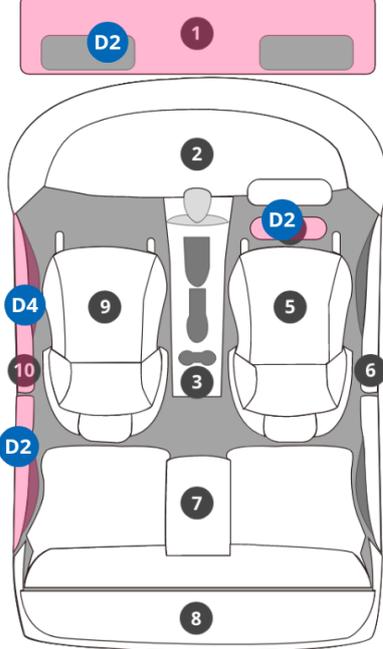
<b>Interior Evaluation :</b> <span style="float: right; color: red; font-weight: bold;">C</span>	<b>Exterior Evaluation :</b> <span style="float: right; color: red; font-weight: bold;">D</span>

<p><b>a</b> : Cut, Fray <b>d</b> : Loose, Deformed <b>k</b> : Animal Hair <b>s</b> : Smell <b>t</b> : Cigarette Burns <b>x</b> : Defective <b>y</b> : Stain</p>

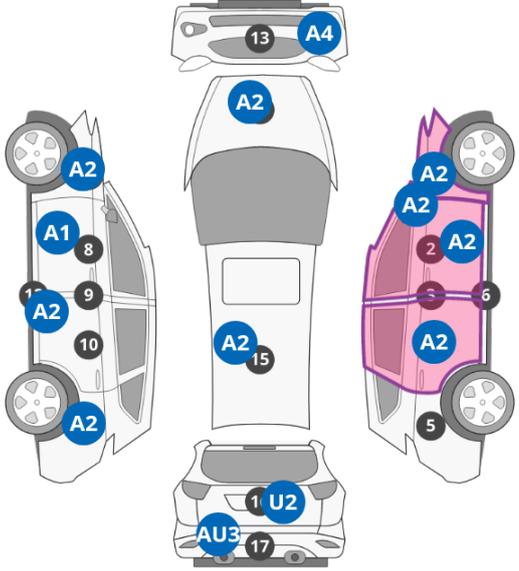
<p><b>A</b> : Scratch <b>AU</b> : Scratch &amp; Dent <b>B</b> : Modified <b>C</b> : Corrosion <b>G</b> : Stone chip <b>P</b> : Faded <b>S</b> : Rust <b>SC</b> : Rust &amp; Corrosion <b>U</b> : Dent <b>X</b> : Defective <b>Y</b> : Crack, Gap</p>
<p><b>Remarks</b> Overall Interior - Worn as per age - Yes / Ceiling - Crinkle - Small / (L) Front Floor Mat - Worked - Small / (L) Rear Trim - Worked - Small / (L) Front Trim - Worked - Large</p>	<p><b>Remarks</b> (R) Front Door - Repair Traces - Yes / (R) Front Fender - Repair Traces - Yes / (R) Rear Door - Repair Traces - Yes / Roof - Repair Traces - Yes / (R) Front Fender, Molding - Repair mark - Yes / (R) Front Door, Molding - Repair mark - Yes / (R) Rear Door, Molding - Repair mark - Yes / (L) Rear Door, Molding - Scratch - Small / (L) Front Fender, Molding - Scratch - Small / (L) Front Door, Molding - Scratch - Minimal / Front Bumper, Grille, Lamps - Scratch - Large / Bonnet, Headlight - Scratch - Small / (R) Mirror - Scratch - Small / (R) Front Door, Molding - Scratch - Small / (R) Front Fender, Molding - Scratch - Small / (R) Rear Door, Molding - Scratch - Small / Rear Bumper, Lamps, Panels - Scratch &amp; Dent - Medium / Trunk Hood, Rear Gate - Dent - Small / (L) Rear Fender, Molding - Scratch - Small / Roof - Scratch - Small</p>
