## General Information

Date & Time: 19, May, 2025 13:16

<b>Make</b>	Toyota	<b>Model</b>	Hiace
<b>YOM</b>	2025	<b>Mileage</b>	3
<b>Registration No.</b>	DA573B	<b>Chassis No.</b>	JTFNAFAP5S8055461
<b>CC</b>	2.8	<b>Transmission</b>	M/T
<b>Fuel Type</b>	Diesel	<b>Type of Body</b>	Van
<b>Colour</b>	Silver

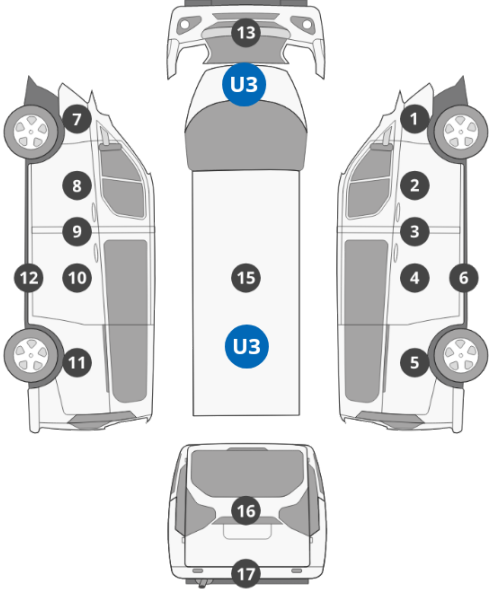
<p><b>A</b> : Scratch <b>AU</b> : Scratch &amp; Dent <b>B</b> : Modified <b>C</b> : Corrosion <b>G</b> : Stone chip <b>P</b> : Faded <b>S</b> : Rust <b>SC</b> : Rust &amp; Corrosion <b>U</b> : Dent <b>X</b> : Defective <b>Y</b> : Crack, Gap</p>
<b>Remarks</b> Defects not found	<b>Remarks</b> Bonnet, Headlight - Dent - Medium / Roof - Dent - Medium
<b>Frame Evaluation :</b> <span style="float: right; color: red; font-weight: bold;">A</span>	<b>Functional Evaluation :</b> <span style="float: right; color: red; font-weight: bold;">A</span>

<b>Inspector Notes</b>
Cluster dents at Hood and roof
