General Information

Date & Time: 03, Jun, 2025 14:00

Make	Toyota	Model	Avanza
YOM	2024	Odo Meter Reading	35,984
Registration No.	NHE9958	Chassis No.	MHFAA1BY4P0020647
CC	1.3	Transmission	M/T
Fuel Type	Gas	Type of Body	MPV
Colour	Green

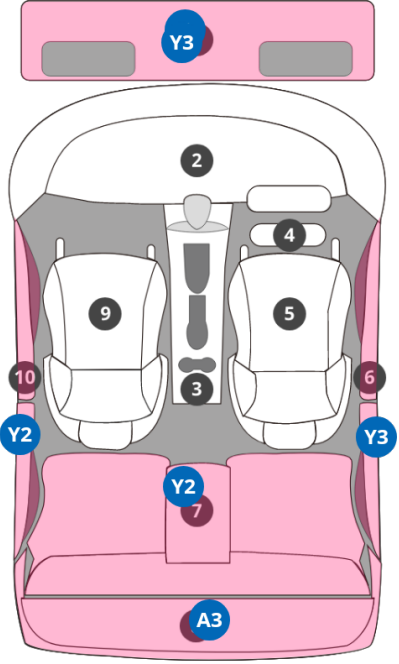
Interior Evaluation : B	Exterior Evaluation : E

<p>a : Cut, Fray d : Loose, Deformed k : Animal Hair s : Smell t : Cigarette Burns x : Defective y : Stain</p>

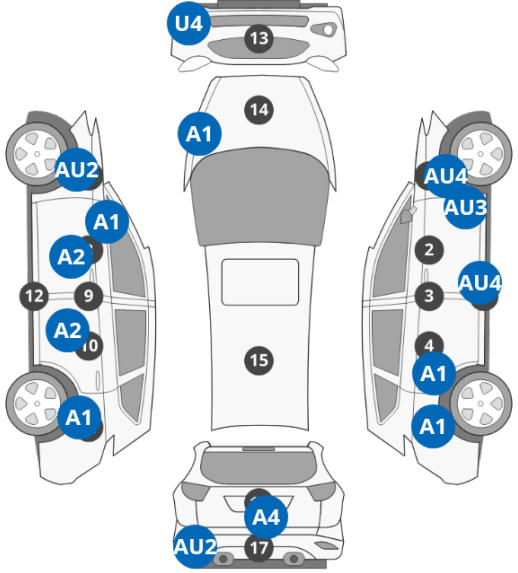
<p>A : Scratch AU : Scratch & Dent B : Modified C : Corrosion G : Stone chip P : Faded S : Rust SC : Rust & Corrosion U : Dent X : Defective Y : Crack, Gap</p>
<p>Remarks (R) Rear Trim - Grime - Medium / Trunk Room - Worn, Scratch, Cut, Crack - Medium / (L) Rear Trim - Grime - Small / Rear Seat - Grime - Small / Overall Interior - Smell - Yes / Ceiling - Grime - Medium</p>	<p>Remarks (R) Front Door - Repair Traces - Yes / (R) Front Fender - Repair Traces - Yes / Bonnet - Repair Traces - Yes / (L) Front Fender - Repair Traces - Yes / (L) Front Door - Repair Traces - Yes / (L) Rear Door - Repair Traces - Yes / (L) Rear Fender - Repair Traces - Yes / Trunk Hood, Rear Gate - Repair Traces - Yes / (R) Rear Fender - Repair Traces - Yes / (R) Rear Door - Repair Traces - Yes / Roof - Repair Traces - Yes / Overall Exterior - Full Re-Paint in same color - Yes / (R) Front Fender, Molding - Scratch & Dent - Large / (R) Step, In-panel, Side Spoiler - Scratch & Dent - Large / (R) Front Door, Molding - Scratch & Dent - Medium / (R) Rear Door, Molding - Scratch - Minimal / (R) Rear Fender, Molding - Scratch - Minimal / Trunk Hood, Rear Gate - Scratch - Large / (L) Rear Fender, Molding - Scratch - Minimal / (L) Rear Door, Molding - Scratch - Small / (L) Front Door, Molding - Scratch - Small / (L) Front Fender, Molding - Scratch & Dent - Small / (L) Mirror - Scratch - Minimal / Front Bumper, Grille, Lamps - Dent - Large / Bonnet, Headlight - Scratch - Minimal / Rear Bumper, Lamps, Panels - Scratch & Dent - Small</p>
