## General Information

| Make | Toyota | Model | Hiace |
| YOM | 2021 | Odo Meter Reading | 103,868 |
| Registration No. | NGP4304 | Chassis No. | JTFNAFAP7L8017229 |

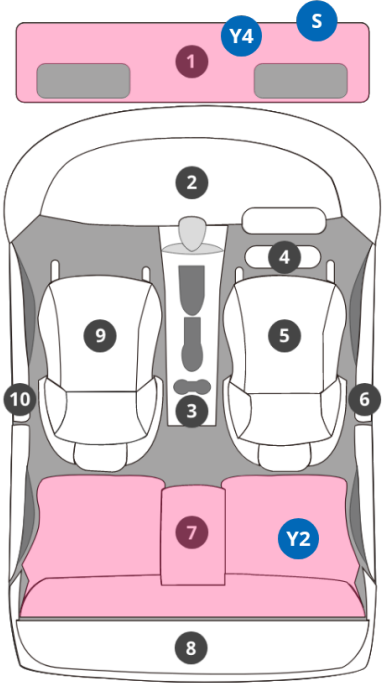
| Interior Evaluation : <span style="color: red;">C</span> | Exterior Evaluation : <span style="color: red;">E</span> |
| <b>Remarks</b><br>Rear Seat - Grime - Small / Overall Interior - Smell - Yes / Ceiling - Grime - Large | <b>Remarks</b><br>(R) Front Fender - Repair Traces - Yes / Trunk Hood, Rear Gate - Repair Traces - Yes / Roof - Repair Traces - Yes / Front Bumper, Grille, Lamps - Repair mark - Yes / Roof - Repair mark - Yes / Front Bumper, Grille, Lamps - Crack, Gap - Medium / Bonnet, Headlight - Scratch & Dent - Small / (R) Mirror - Scratch - Minimal / (R) Step, In-panel, Side Spoiler - Scratch & Dent - Small / (R) Front Door, Molding - Scratch - Small / (R) Rear Door, Molding - Scratch & Dent - Medium / (R) Rear Fender, Molding - Scratch - Small / Trunk Hood, Rear Gate - Scratch & Dent - Medium / Rear Bumper, Lamps, Panels - Scratch - Medium / (L) Rear Fender, Molding - Scratch - Medium / (L) Rear Door, Molding - Scratch - Medium / (L) Mirror - Scratch - Small / (L) Front Fender, Molding - Scratch - Small / Roof - Dent - Large |
