## General Information

Date & Time: 02, Jun, 2025 10:42

<b>Make</b>	Toyota	<b>Model</b>	Vios
<b>YOM</b>	2024	<b>Odo Meter Reading</b>	17,856
<b>Registration No.</b>	NFS8204	<b>Chassis No.</b>	PA1B18F39P4234604
<b>CC</b>	1.3	<b>Transmission</b>	CVT
<b>Fuel Type</b>	Gas	<b>Type of Body</b>	Sedan
<b>Colour</b>	Red Mica Metallic

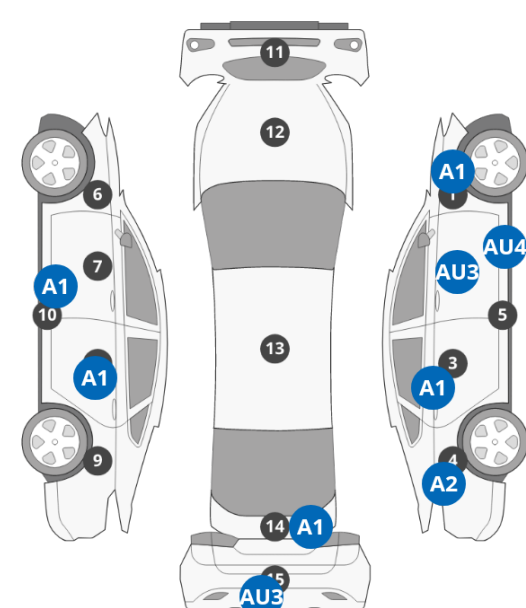
<p><b>A</b> : Scratch <b>AU</b> : Scratch &amp; Dent <b>B</b> : Modified <b>C</b> : Corrosion <b>G</b> : Stone chip <b>P</b> : Faded <b>S</b> : Rust <b>SC</b> : Rust &amp; Corrosion <b>U</b> : Dent <b>X</b> : Defective <b>Y</b> : Crack, Gap</p>
<p><b>Remarks</b> (R) Front Seat - Grime - Large / (L) Front Seat - Grime - Medium / Rear Seat - Grime - Medium / (R) Front Trim - Grime - Minimal / (L) Front Floor Mat - Worked - Small / (L) Front Trim - Grime - Minimal</p>	<p><b>Remarks</b> (R) Step, In-panel, Side Spoiler - Scratch &amp; Dent - Large / (R) Front Fender, Molding - Scratch - Minimal / (R) Front Door, Molding - Scratch &amp; Dent - Medium / Rear Bumper, Lamps, Panels - Scratch &amp; Dent - Medium / (R) Rear Fender, Molding - Scratch - Small / (R) Rear Door, Molding - Scratch - Minimal / Trunk Hood, Rear Gate - Scratch - Minimal / (L) Front Door, Molding - Scratch - Minimal / (L) Rear Door, Molding - Scratch - Minimal</p>
