## General Information

<b>Make</b>	Toyota	<b>Model</b>	Vios
<b>YOM</b>	2024	<b>Odo Meter Reading</b>	10,391
<b>Registration No.</b>	NFR9419	<b>Chassis No.</b>	PA1B18F38R4258637
<b>CC</b>	1.3	<b>Transmission</b>	CVT
<b>Fuel Type</b>	Gas	<b>Type of Body</b>	Sedan
<b>Colour</b>	Red

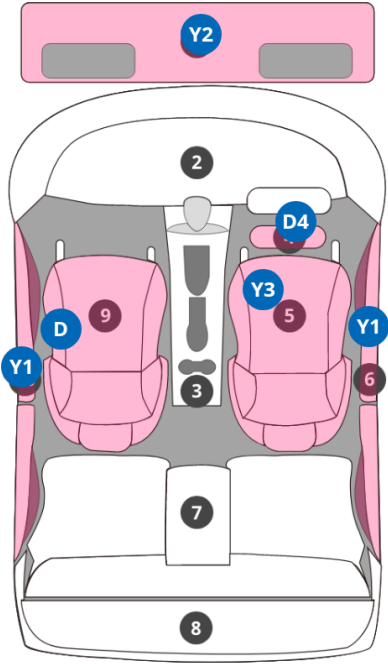
<b>Interior Evaluation :</b> <span style="float: right; color: red; font-weight: bold;">C</span>	<b>Exterior Evaluation :</b> <span style="float: right; color: red; font-weight: bold;">C</span>

<p><b>A</b> : Scratch <b>AU</b> : Scratch &amp; Dent <b>B</b> : Modified <b>C</b> : Corrosion <b>G</b> : Stone chip <b>P</b> : Faded <b>S</b> : Rust <b>SC</b> : Rust &amp; Corrosion <b>U</b> : Dent <b>X</b> : Defective <b>Y</b> : Crack, Gap</p>
<p><b>Remarks</b> (R) Front Seat - Grime - Medium / (L) Front Seat - Worn - Yes / (R) Front Trim - Grime - Minimal / (L) Front Floor Mat - Worked - Large / (L) Front Trim - Grime - Minimal / Ceiling - Grime - Small</p>	<p><b>Remarks</b> (L) Front Fender - Repair Traces - Yes / (L) Rear Door - Repair Traces - Yes / (L) Rear Fender - Repair Traces - Yes / (R) Front Fender, Molding - Scratch - Small / (R) Front Door, Molding - Scratch &amp; Dent - Small / (R) Step, In-panel, Side Spoiler - Scratch &amp; Dent - Medium / (R) Rear Door, Molding - Scratch &amp; Dent - Small / Rear Bumper, Lamps, Panels - Repair mark - Yes / Rear Bumper, Lamps, Panels - Scratch - Small / (L) Rear Fender, Molding - Scratch - Small / (L) Front Door, Molding - Scratch - Small / Front Bumper, Grille, Lamps - Repair mark - Yes / Front Bumper, Grille, Lamps - Scratch - Large / Bonnet, Headlight - Scratch &amp; Dent - Medium</p>

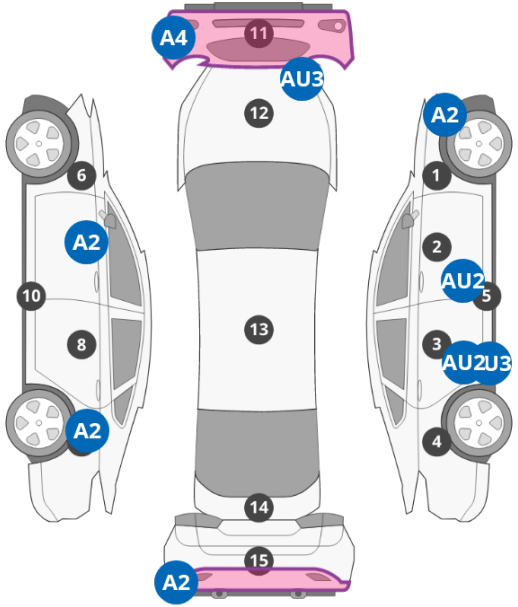
<p><b>Inspector Notes</b></p>
<p>no warranty booklet, with jack, incomplete tools, with spare tire, with LTO plate but not attached, scratches on headlight</p>
