## General Information

<b>Make</b>	Toyota	<b>Model</b>	Vios
<b>YOM</b>	2024	<b>Odo Meter Reading</b>	30,810
<b>Registration No.</b>	NHS4776	<b>Chassis No.</b>	PA1B18F3XR4261023
<b>CC</b>	1.3	<b>Transmission</b>	CVT
<b>Fuel Type</b>	Gas	<b>Type of Body</b>	Sedan
<b>Colour</b>	Red

## Body / Panel Condition

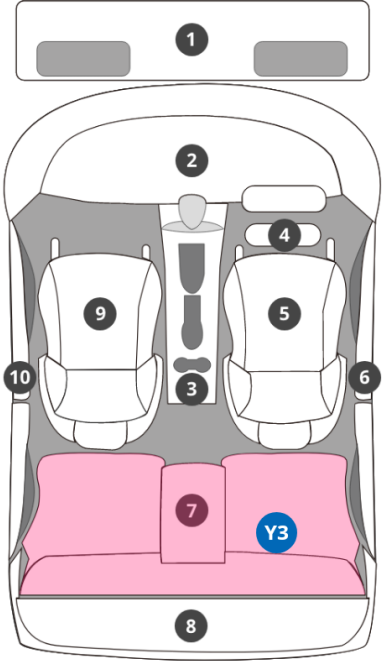
<b>Interior Evaluation :</b> <span style="float: right;"><b>B</b></span>	<b>Exterior Evaluation :</b> <span style="float: right;"><b>C</b></span>

<p><b>A</b> : Scratch <b>AU</b> : Scratch &amp; Dent <b>B</b> : Modified <b>C</b> : Corrosion <b>G</b> : Stone chip <b>P</b> : Faded <b>S</b> : Rust <b>SC</b> : Rust &amp; Corrosion <b>U</b> : Dent <b>X</b> : Defective <b>Y</b> : Crack, Gap</p>
<b>Remarks</b> Rear Seat - Grime - Medium	<b>Remarks</b> (R) Front Fender, Molding - Scratch - Minimal / (R) Step, In-panel, Side Spoiler - Dent - Medium / (R) Rear Fender, Molding - Scratch & Dent - Large / (R) Front Door, Molding - Scratch & Dent - Small / (R) Rear Door, Molding - Scratch & Dent - Small / Rear Bumper, Lamps, Panels - Scratch & Dent - Medium / Trunk Hood, Rear Gate - Scratch - Minimal / (L) Front Door, Molding - Scratch & Dent - Small / (L) Rear Door, Molding - Scratch - Minimal / Front Bumper, Grille, Lamps - Scratch - Small
