## General Information

Date & Time: 29, May, 2025 14:04

<b>Make</b>	Suzuki	<b>Model</b>	Carry
<b>YOM</b>	2024	<b>Odo Meter Reading</b>	11,409
<b>Registration No.</b>	NKB3560	<b>Chassis No.</b>	MHYDC61T1SJ210023
<b>CC</b>	1.5	<b>Transmission</b>	M/T
<b>Fuel Type</b>	Gas	<b>Type of Body</b>	Van
<b>Colour</b>	White

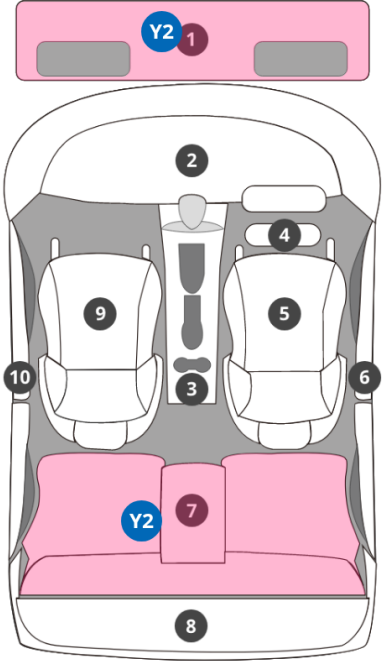
<b>Interior Evaluation :</b> <span style="float: right; color: red; font-weight: bold;">A</span>	<b>Exterior Evaluation :</b> <span style="float: right; color: red; font-weight: bold;">D</span>

<p><b>A</b> : Scratch <b>AU</b> : Scratch &amp; Dent <b>B</b> : Modified <b>C</b> : Corrosion <b>G</b> : Stone chip <b>P</b> : Faded <b>S</b> : Rust <b>SC</b> : Rust &amp; Corrosion <b>U</b> : Dent <b>X</b> : Defective <b>Y</b> : Crack, Gap</p>
<b>Remarks</b> Rear Seat - Grime - Small / Ceiling - Grime - Small	<b>Remarks</b> Front Panel - Repair Traces - Yes / (L) Rear Corner Panel - Repair Traces - Yes / (R) Front Fender, Molding - Scratch - Small / (R) Center Panel - Scratch - Minimal / (R) Side Gate - Scratch & Dent - Medium / Cargo Bed Floor - Scratch & Dent - Large / Rear Bumper, Lamps, Panels - Rust, Corrosion - Large / Rear Gate - Scratch - Small / (L) Side Gate - Scratch - Small / Front Panel - Scratch - Small / Front Bumper, Grille, Lamps - Scratch - Small / (L) Front Fender, Molding - Scratch - Minimal / (L) Front Door, Molding - Scratch - Small / Roof - Scratch & Dent - Large
