## General Information

Date & Time: 03, Jun, 2025 09:33

<b>Make</b>	Toyota	<b>Model</b>	Vios
<b>YOM</b>	2024	<b>Odo Meter Reading</b>	23,133
<b>Registration No.</b>	NHM6317	<b>Chassis No.</b>	PA1B18F33R4239946
<b>CC</b>	1.3	<b>Transmission</b>	CVT
<b>Fuel Type</b>	Gas	<b>Type of Body</b>	Sedan
<b>Colour</b>	Red

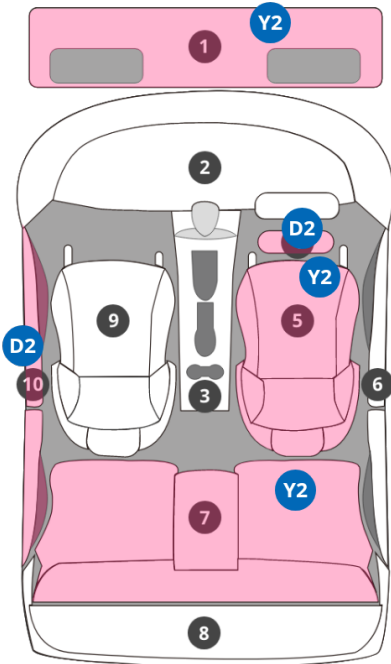
<b>Interior Evaluation :</b> <span style="float: right; color: red; font-weight: bold;">A</span>	<b>Exterior Evaluation :</b> <span style="float: right; color: red; font-weight: bold;">C</span>

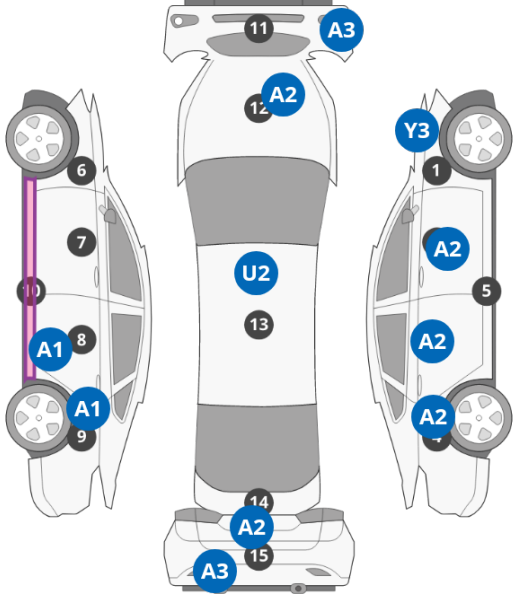
<p><b>A</b> : Scratch <b>AU</b> : Scratch &amp; Dent <b>B</b> : Modified <b>C</b> : Corrosion <b>G</b> : Stone chip <b>P</b> : Faded <b>S</b> : Rust <b>SC</b> : Rust &amp; Corrosion <b>U</b> : Dent <b>X</b> : Defective <b>Y</b> : Crack, Gap</p>
<p><b>Remarks</b> Ceiling - Grime - Small / (L) Front Floor Mat - Worked - Small / Rear Seat - Grime - Small / (R) Front Seat - Grime - Small</p>	<p><b>Remarks</b> Roof - Dent - Small / (L) Step, In-panel, Side Spoiler - Repair mark - Yes / (L) Rear Door, Molding - Scratch - Minimal / (L) Rear Fender, Molding - Scratch - Minimal / Front Bumper, Grille, Lamps - Scratch - Medium / (R) Front Fender, Molding - Crack, Gap - Medium / Bonnet, Headlight - Scratch - Small / (R) Front Door, Molding - Scratch - Small / (R) Rear Door, Molding - Scratch - Small / (R) Rear Fender, Molding - Scratch - Small / Trunk Hood, Rear Gate - Scratch - Small / Rear Bumper, Lamps, Panels - Scratch - Medium</p>
