General Information

| Make | Suzuki | Model | APV |
| Registration No. | NIU2560 | Chassis No. | MHYDN71V3RJ401177 |

Body / Panel Condition

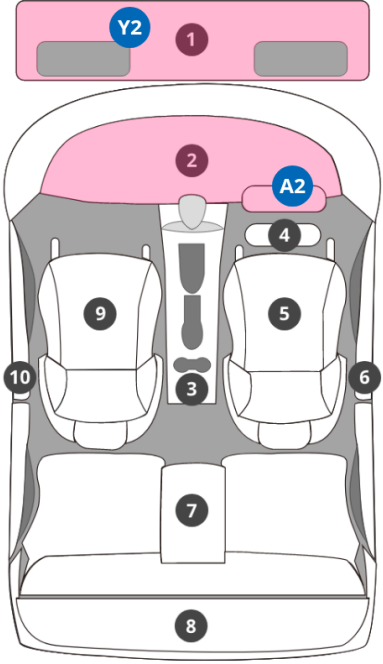
| <p>Remarks Overall Interior - Worn as per age - Yes / Glove Box - Worn, Scratch, Cut, Crack - Small / Ceiling - Grime - Small</p> | <p>Remarks (R) Front Door, Molding - Scratch & Dent - Small / Trunk Hood, Rear Gate - Scratch - Small / (L) Front Door, Molding - Scratch & Dent - Minimal / (R) Rear Fender, Molding - Scratch - Minimal / (R) Rear Door, Molding - Scratch - Medium / (L) Rear Door, Molding - Scratch - Small / (L) Rear Fender, Molding - Scratch - Minimal / Front Bumper, Grille, Lamps - Scratch & Dent - Minimal / Bonnet, Headlight - Scratch - Small / (L) Front Fender, Molding - Scratch - Small / (R) Front Fender, Molding - Scratch - Small / Roof - Scratch - Small</p> |
