## General Information

Date & Time: 30, May, 2025 13:05

<b>Make</b>	Toyota	<b>Model</b>	Vios
<b>YOM</b>	2023	<b>Odo Meter Reading</b>	23,912
<b>Registration No.</b>	NIJ2171	<b>Chassis No.</b>	PA1B18F39P4203370
<b>CC</b>	1.3	<b>Transmission</b>	CVT
<b>Fuel Type</b>	Gas	<b>Type of Body</b>	Sedan
<b>Colour</b>	Red Mica Metallic

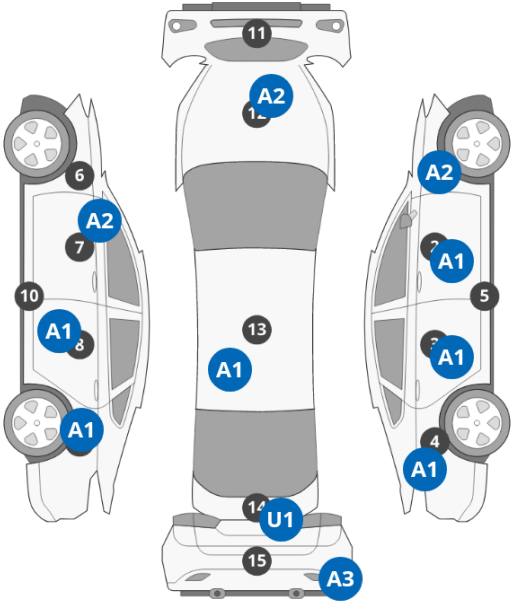
<p><b>A</b> : Scratch <b>AU</b> : Scratch &amp; Dent <b>B</b> : Modified <b>C</b> : Corrosion <b>G</b> : Stone chip <b>P</b> : Faded <b>S</b> : Rust <b>SC</b> : Rust &amp; Corrosion <b>U</b> : Dent <b>X</b> : Defective <b>Y</b> : Crack, Gap</p>
<p><b>Remarks</b> (R) Front Seat - Grime - Minimal / (L) Front Trim - Grime - Small / (L) Front Floor Mat - Worked - Small / Overall Interior - Animal Hair - Yes / Ceiling - Grime - Small</p>	<p><b>Remarks</b> (R) Rear Fender - Repair Traces - Yes / (R) Front Fender, Molding - Scratch - Small / (R) Front Door, Molding - Scratch - Minimal / (R) Rear Door, Molding - Scratch - Minimal / (R) Rear Fender, Molding - Scratch - Minimal / Rear Bumper, Lamps, Panels - Scratch - Medium / Trunk Hood, Rear Gate - Dent - Minimal / (L) Rear Door, Molding - Scratch - Minimal / (L) Rear Fender, Molding - Scratch - Minimal / (L) Mirror - Scratch - Small / Bonnet, Headlight - Scratch - Small / Roof - Scratch - Minimal</p>
