## General Information

<b>Make</b>	Toyota	<b>Model</b>	Vios
<b>YOM</b>	2023	<b>Odo Meter Reading</b>	55,635
<b>Registration No.</b>	CCB2060	<b>Chassis No.</b>	PA1B18F39P4208407
<b>CC</b>	1.3	<b>Transmission</b>	CVT
<b>Fuel Type</b>	Gas	<b>Type of Body</b>	Sedan
<b>Colour</b>	Blue

## Body / Panel Condition

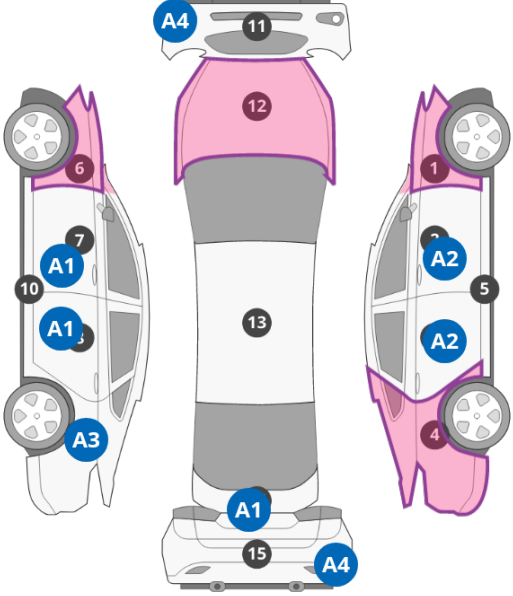
<p><b>A</b> : Scratch <b>AU</b> : Scratch &amp; Dent <b>B</b> : Modified <b>C</b> : Corrosion <b>G</b> : Stone chip <b>P</b> : Faded <b>S</b> : Rust <b>SC</b> : Rust &amp; Corrosion <b>U</b> : Dent <b>X</b> : Defective <b>Y</b> : Crack, Gap</p>
<p><b>Remarks</b> (L) Front Trim - Worked - Small / Rear Seat - Grime - Large / (R) Front Seat - Grime - Small / Ceiling - Grime - Minimal</p>	<p><b>Remarks</b> (R) Front Fender - Repair Traces - Yes / Bonnet - Repair Traces - Yes / (L) Front Fender - Repair Traces - Yes / Trunk Hood, Rear Gate - Repair Traces - Yes / (R) Rear Fender - Repair Traces - Yes / Bonnet, Headlight - Repair mark - Yes / (R) Front Fender, Molding - Repair mark - Yes / (L) Front Fender, Molding - Repair mark - Yes / (R) Rear Fender, Molding - Repair mark - Yes / (R) Front Door, Molding - Scratch - Small / (R) Rear Door, Molding - Scratch - Small / Trunk Hood, Rear Gate - Scratch - Minimal / Rear Bumper, Lamps, Panels - Scratch - Large / (L) Rear Fender, Molding - Scratch - Medium / (L) Rear Door, Molding - Scratch - Minimal / (L) Front Door, Molding - Scratch - Minimal / Front Bumper, Grille, Lamps - Scratch - Large</p>
