General Information

| Make | Toyota | Model | Avanza |
| Registration No. | NFC3403 | Chassis No. | MHKM5EF2FMK028535 |

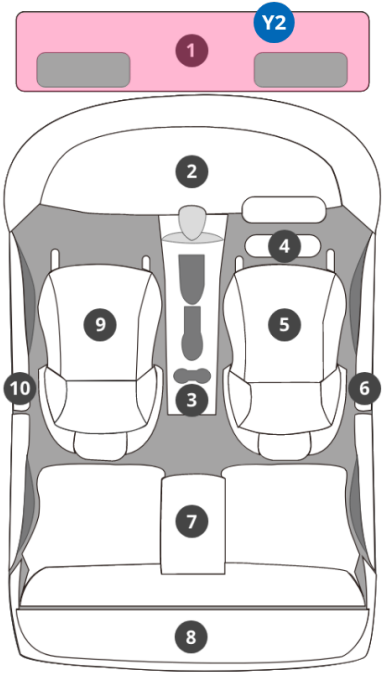
| Interior Evaluation : C | Exterior Evaluation : B |
| <p>Remarks Ceiling - Grime - Small / Overall Interior - Worn as per age - Yes</p> | <p>Remarks (L) Rear Fender, Molding - Scratch & Dent - Small / (R) Rear Fender, Molding - Scratch - Small / Trunk Hood, Rear Gate - Scratch - Small / (R) Rear Door, Molding - Scratch - Small / (R) Mirror - Scratch - Small / (R) Front Door, Molding - Scratch - Small / Front Bumper, Grille, Lamps - Scratch - Medium / Bonnet, Headlight - Scratch - Small</p> |

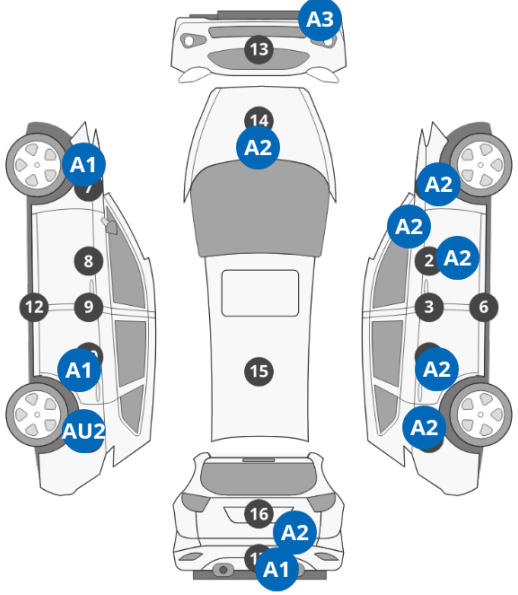
| <p>With LTO plate and Jack, Spare tire and incomplete tools. scratch and crack on tail light.</p> |
