General Information

Make	Toyota	Model	Vios
YOM	2023	Odo Meter Reading	92,097
Registration No.	NIG2132	Chassis No.	PA1B18F32N4197571
CC	1.3	Transmission	CVT
Fuel Type	Gas	Type of Body	Sedan
Colour	Blue

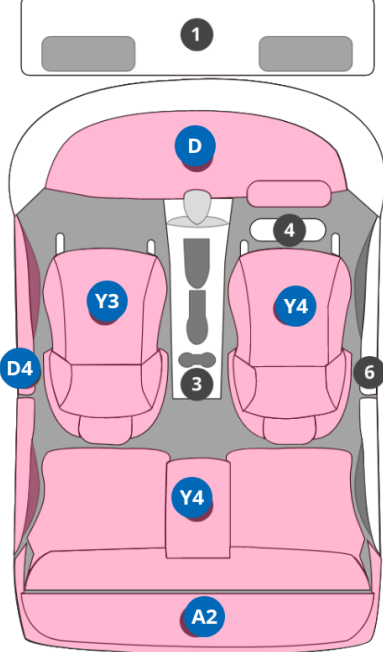
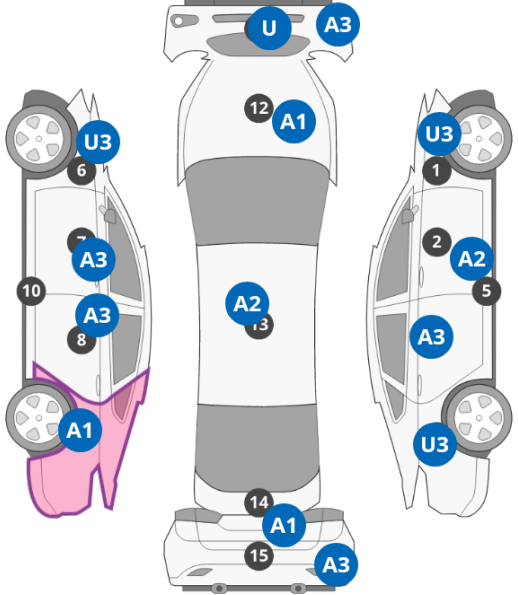
Interior Evaluation :	C	Exterior Evaluation :	E

<p>a : Cut, Fray d : Loose, Deformed k : Animal Hair s : Smell t : Cigarette Burns x : Defective y : Stain</p>		<p>A : Scratch AU : Scratch & Dent B : Modified C : Corrosion G : Stone chip P : Faded S : Rust SC : Rust & Corrosion U : Dent X : Defective Y : Crack, Gap</p>	
<p>Remarks Trunk Room - Worn, Scratch, Cut, Crack - Small / (R) Front Seat - Grime - Large / Rear Seat - Grime - Large / (L) Front Trim - Worked - Large / (L) Front Seat - Grime - Medium / Dashboard - Traces of Adhesive Tape - Yes</p>		<p>Remarks (L) Rear Fender - Repair Traces - Yes / (L) Rear Fender, Molding - Repair mark - Yes / (R) Front Fender, Molding - Dent - Medium / (R) Front Door, Molding - Scratch - Small / (R) Rear Door, Molding - Scratch - Medium / (R) Rear Fender, Molding - Dent - Medium / Roof - Scratch - Small / Rear Bumper, Lamps, Panels - Scratch - Medium / Trunk Hood, Rear Gate - Scratch - Minimal / (L) Rear Fender, Molding - Scratch - Minimal / (L) Rear Door, Molding - Scratch - Medium / (L) Front Door, Molding - Scratch - Medium / (L) Front Fender, Molding - Dent - Medium / Member (Bolted) - Dent - Yes / Front Bumper, Grille, Lamps - Scratch - Medium / Bonnet, Headlight - Scratch - Minimal</p>
