## General Information

<b>Make</b>	Suzuki	<b>Model</b>	Dzire
<b>YOM</b>	2023	<b>Odo Meter Reading</b>	13,729
<b>Registration No.</b>	NFB2314	<b>Chassis No.</b>	MBHZF63S1RG370099
<b>CC</b>	1.2	<b>Transmission</b>	A/T
<b>Fuel Type</b>	Gas	<b>Type of Body</b>	Sedan
<b>Colour</b>	Blue

## Body / Panel Condition

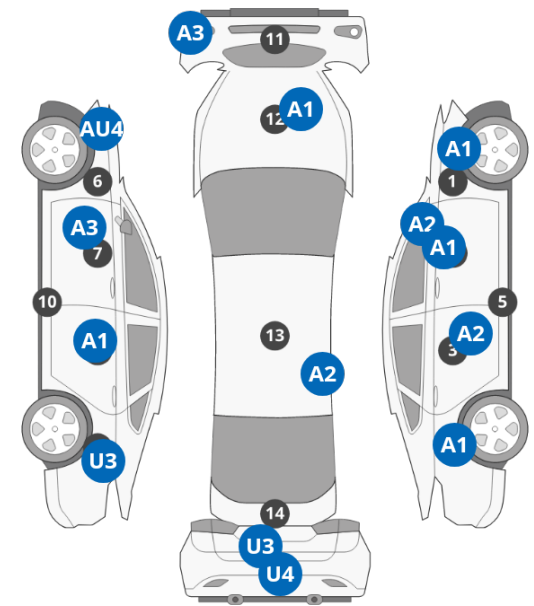
<p><b>A</b> : Scratch <b>AU</b> : Scratch &amp; Dent <b>B</b> : Modified <b>C</b> : Corrosion <b>G</b> : Stone chip <b>P</b> : Faded <b>S</b> : Rust <b>SC</b> : Rust &amp; Corrosion <b>U</b> : Dent <b>X</b> : Defective <b>Y</b> : Crack, Gap</p>
<p><b>Remarks</b>  (R) Front Trim - Worked - Small / (R) Front Seat - Grime - Minimal / Rear Seat - Grime - Large / (L) Front Trim - Worked - Large / Ceiling - Grime - Minimal</p>	<p><b>Remarks</b>  (R) Front Fender, Molding - Scratch - Minimal / (R) Mirror - Scratch - Small / (R) Front Door, Molding - Scratch - Minimal / (R) Rear Door, Molding - Scratch - Small / (R) Rear Fender, Molding - Scratch - Minimal / Rear Bumper, Lamps, Panels - Dent - Large / (L) Rear Fender, Molding - Dent - Medium / (L) Rear Door, Molding - Scratch - Minimal / (L) Front Door, Molding - Scratch - Medium / (L) Front Fender, Molding - Scratch &amp; Dent - Large / Roof - Scratch - Small / Front Bumper, Grille, Lamps - Scratch - Medium / Bonnet, Headlight - Scratch - Minimal / Trunk Hood, Rear Gate - Dent - Medium</p>
