General Information

Make	Toyota	Model	Hiace
YOM	2021	Odo Meter Reading	43,674
Registration No.	NGU3716	Chassis No.	JTFJT02P5L5026226
CC	3.0	Transmission	M/T
Fuel Type	Diesel	Type of Body	Van
Colour	White

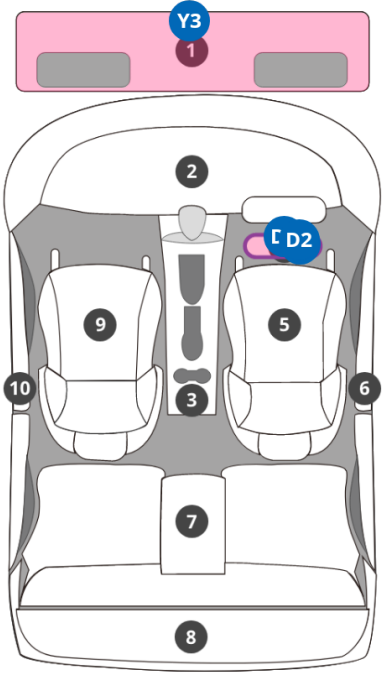
Interior Evaluation : C	Exterior Evaluation : D

<p>A : Scratch AU : Scratch & Dent B : Modified C : Corrosion G : Stone chip P : Faded S : Rust SC : Rust & Corrosion U : Dent X : Defective Y : Crack, Gap</p>
<p>Remarks Overall Interior - Worn as per age - Yes / Carpet - Worked - Minimal / Mat Other - Missing - Yes / (L) Front Floor Mat - Worked - Small / Ceiling - Grime - Medium</p>	<p>Remarks (R) Front Door - Repair Traces - Yes / (L) Front Door - Repair Traces - Yes / (R) Rear Door - Repair Traces - Yes / (R) Center Panel - Repair Traces - Yes / (L) Front Door, Molding - Repair mark - Yes / (L) Front Fender, Molding - Repair mark - Yes / Front Windshield - Damaged - Large / Front Panel - Rust, Corrosion - Small / Front Bumper, Grille, Lamps - Scratch - Large / (R) Front Door, Molding - Scratch & Dent - Small / (R) Rear Door, Molding - Scratch & Dent - Small / (R) Rear Fender, Molding - Scratch - Medium / Trunk Hood, Rear Gate - Scratch - Minimal / (L) Rear Fender, Molding - Scratch - Small / (L) Front Door, Molding - Crack, Gap - Medium / (L) Center Panel - Scratch - Small / (R) Front Fender, Molding - Scratch & Dent - Small</p>
