## General Information

| Make | Toyota | Model | Vios |
| YOM | 2024 | Mileage | 4,878 |
| Registration No. | DBM6507 | Chassis No. | PA1B18F32R4244233 |

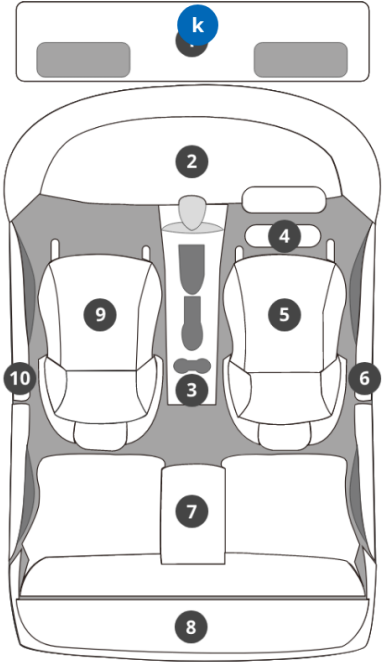
| Interior Evaluation : <b>B</b> | Exterior Evaluation : <b>C</b> |
| <b>Remarks</b><br>Overall Interior - Animal Hair - Yes | <b>Remarks</b><br>Front Bumper, Grille, Lamps - Scratch & Dent - Large / (L) Mirror - Scratch - Small / (L) Front Door, Molding - Scratch - Minimal / Rear Bumper, Lamps, Panels - Scratch - Small / (R) Rear Fender, Molding - Scratch & Dent - Minimal / Trunk Hood, Rear Gate - Scratch & Dent - Small |

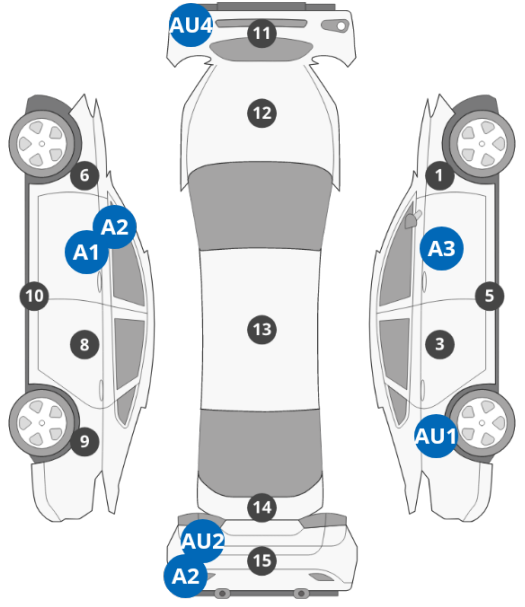
more light scratches at the front bumper and rear trunk. swirl marks and hairline scratches around the exterior. Low washer fluid level.
