## General Information

<b>Make</b>	Toyota	<b>Model</b>	Avanza
<b>YOM</b>	2024	<b>Odo Meter Reading</b>	15,509
<b>Registration No.</b>	BAG3472	<b>Chassis No.</b>	MHFAA1BYOR0023242
<b>CC</b>	1.3	<b>Transmission</b>	M/T
<b>Fuel Type</b>	Gas	<b>Type of Body</b>	MPV
<b>Colour</b>	White

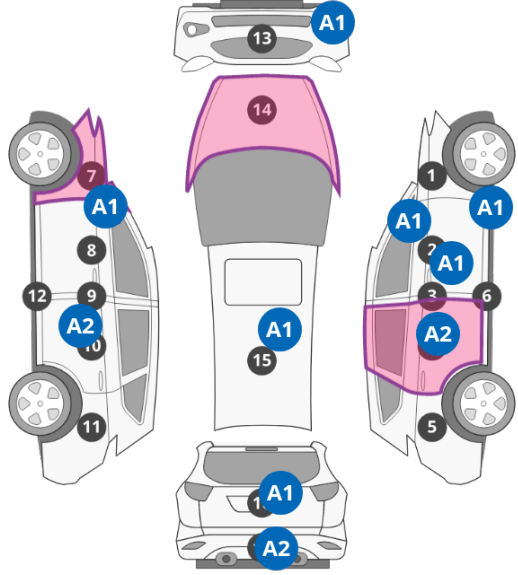
<p><b>A</b> : Scratch <b>AU</b> : Scratch &amp; Dent <b>B</b> : Modified <b>C</b> : Corrosion <b>G</b> : Stone chip <b>P</b> : Faded <b>S</b> : Rust <b>SC</b> : Rust &amp; Corrosion <b>U</b> : Dent <b>X</b> : Defective <b>Y</b> : Crack, Gap</p>
<p><b>Remarks</b> Trunk Room - Worn, Scratch, Cut, Crack - Small / Rear Seat - Grime - Minimal / (R) Front Trim - Worked - Small / Dashboard - Worn, Scratch, Cut, Crack - Minimal</p>	<p><b>Remarks</b> Bonnet - Repair Traces - Yes / (L) Front Fender - Repair Traces - Yes / (R) Rear Door - Repair Traces - Yes / (R) Mirror - Scratch - Minimal / (R) Step, In-panel, Side Spoiler - Scratch - Minimal / (R) Front Door, Molding - Scratch - Minimal / (R) Rear Door, Molding - Scratch - Small / Trunk Hood, Rear Gate - Scratch - Minimal / Rear Bumper, Lamps, Panels - Scratch - Small / (L) Rear Door, Molding - Scratch - Small / (L) Mirror - Scratch - Minimal / Front Bumper, Grille, Lamps - Scratch - Minimal / Roof - Scratch - Minimal / Overall Exterior - Full Re-Paint in same color - Yes / (R) Rear Door, Molding - Repair mark - Yes / Bonnet, Headlight - Repair mark - Yes / (L) Front Fender, Molding - Repair mark - Yes</p>
