General Information

Make	Toyota	Model	Lite Ace
YOM	2023	Odo Meter Reading	11,827
Registration No.	DBH9930	Chassis No.	MHKU3FE10PK003627
CC	1.5	Transmission	M/T
Fuel Type	Gas	Type of Body	Van
Colour	White

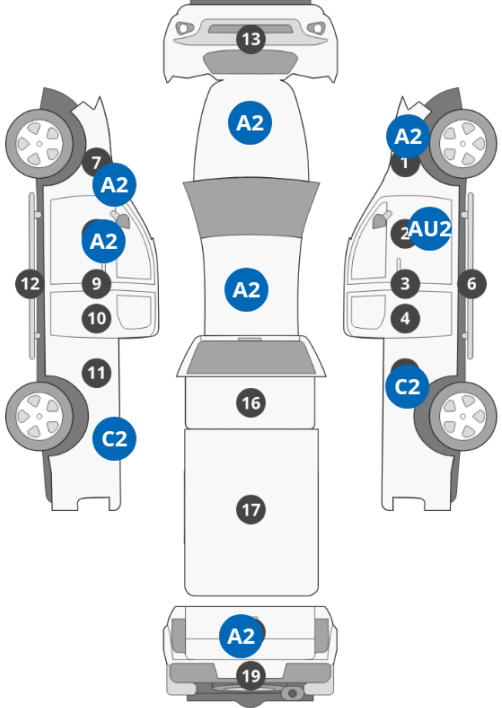
<p>A : Scratch AU : Scratch & Dent B : Modified C : Corrosion G : Stone chip P : Faded S : Rust SC : Rust & Corrosion U : Dent X : Defective Y : Crack, Gap</p>
Remarks Defects not found	Remarks (R) Rear Corner Panel - Repair Traces - Yes / (L) Front Door, Molding - Scratch - Small / (L) Front Fender, Molding - Scratch - Small / (L) Rear Wheel, Cover - Scratch, Corrosion - Small / (R) Front Fender, Molding - Scratch - Small / (R) Front Door, Molding - Scratch & Dent - Small / (R) Rear Wheel, Cover - Scratch, Corrosion - Small / Rear Gate - Scratch - Small / Front Panel - Scratch - Small / Roof - Scratch - Small
Frame Evaluation : A	Functional Evaluation : A
Remarks Defects not found	Remarks Reverse Camera - N/A - Yes
