## General Information

| Make | Toyota | Model | Hiace |
| Registration No. | NDM4559 | Chassis No. | JTFJT02PXXK0013175 |

## Body / Panel Condition

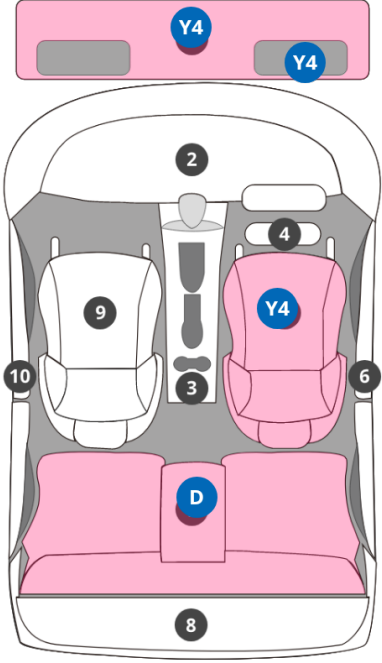
| Interior Evaluation : <b>C</b> | Exterior Evaluation : <b>E</b> |
|---|---|
| <b>Remarks</b><br>(R) Front Seat - Grime - Large / Sunvisor, Sunglass Holder - Grime - Large / Ceiling - Grime - Large / Rear Seat - Worn - Yes | <b>Remarks</b><br>Trunk Hood, Rear Gate - Repair Traces - Yes / (R) Rear Door - Repair Traces - Yes / Trunk Hood, Rear Gate - Repair mark - Yes / (R) Rear Door, Molding - Repair mark - Yes / (L) Front Fender, Molding - Repair mark - Yes / (R) Front Fender, Molding - Repair mark - Yes / Roof - Dent - Small / (L) Rear Fender, Molding - Scratch & Dent - Large / (L) Front Door, Molding - Scratch & Dent - Small / Bonnet, Headlight - Scratch & Dent - Medium / Front Bumper, Grille, Lamps - Crack, Gap - Large / (R) Mirror - Scratch - Small / (L) Mirror - Scratch - Small / (R) Front Door, Molding - Repair mark - Yes / (R) Front Door, Molding - Scratch - Medium / (R) Rear Fender, Molding - Repair mark - Yes / (R) Rear Fender, Molding - Scratch - Medium / Trunk Hood, Rear Gate - Scratch & Dent - Small / Rear Bumper, Lamps, Panels - Scratch & Dent - Medium / (R) Rear Door, Molding - Scratch & Dent - Small |
