## General Information

<b>Make</b>	Mitsubishi	<b>Model</b>	Montero SPT
<b>YOM</b>	2018	<b>Mileage</b>	58,870
<b>Registration No.</b>	NBR9007	<b>Chassis No.</b>	MMBOUKR10JH021712
<b>CC</b>	2.5	<b>Transmission</b>	A/T
<b>Fuel Type</b>	Diesel	<b>Type of Body</b>	SUV
<b>Colour</b>	Silver

## Body / Panel Condition

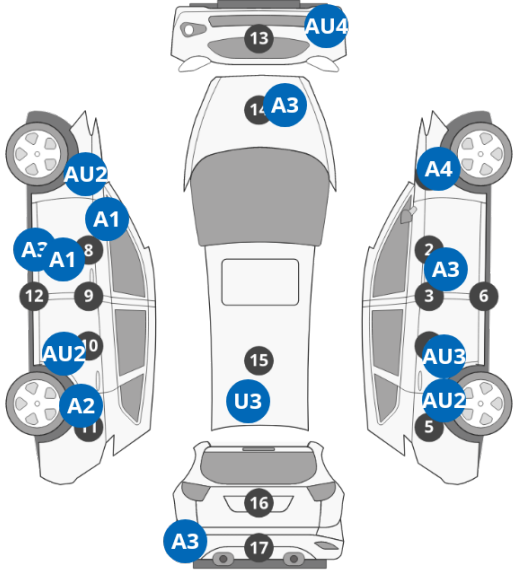
<p><b>A</b> : Scratch <b>AU</b> : Scratch &amp; Dent <b>B</b> : Modified <b>C</b> : Corrosion <b>G</b> : Stone chip <b>P</b> : Faded <b>S</b> : Rust <b>SC</b> : Rust &amp; Corrosion <b>U</b> : Dent <b>X</b> : Defective <b>Y</b> : Crack, Gap</p>
<p><b>Remarks</b> (R) Front Seat - Grime - Medium / (R) Front Floor Mat - Missing - Yes / Mat Other - Missing - Yes / (L) Front Floor Mat - Missing - Yes / Ceiling - Grime - Small / (R) Front Trim - Grime - Small / (R) Rear Trim - Grime - Small / Rear Seat - Grime - Medium / (L) Front Trim - Grime - Small / (L) Front Seat - Cut, Crack - Medium / Console, Switches, Vents - Worn, Scratch, Cut, Crack - Small / Overall Interior - Smell - Yes</p>	<p><b>Remarks</b> Front Bumper, Grille, Lamps - Scratch &amp; Dent - Large / (R) Front Fender, Molding - Scratch - Large / (R) Rear Door, Molding - Scratch &amp; Dent - Medium / (R) Rear Fender, Molding - Scratch &amp; Dent - Small / (R) Front Door, Molding - Scratch - Medium / (L) Step, In-panel, Side Spoiler - Scratch - Medium / (L) Rear Fender, Molding - Scratch - Small / (L) Rear Door, Molding - Scratch &amp; Dent - Small / (L) Front Door, Molding - Scratch - Minimal / (L) Mirror - Scratch - Minimal / (L) Front Fender, Molding - Scratch &amp; Dent - Small / Bonnet, Headlight - Scratch - Medium / Rear Bumper, Lamps, Panels - Scratch - Medium / Roof - Dent - Medium</p>
