### General Information

Date & Time: 26, May, 2025 14:34

<b>Make</b>	Toyota	<b>Model</b>	Hiace
<b>YOM</b>	2025	<b>Mileage</b>	8
<b>Registration No.</b>	DA393B	<b>Chassis No.</b>	JTFPA9AP9S8055439
<b>CC</b>	2.8	<b>Transmission</b>	M/T
<b>Fuel Type</b>	Diesel	<b>Type of Body</b>	Van
<b>Colour</b>	White

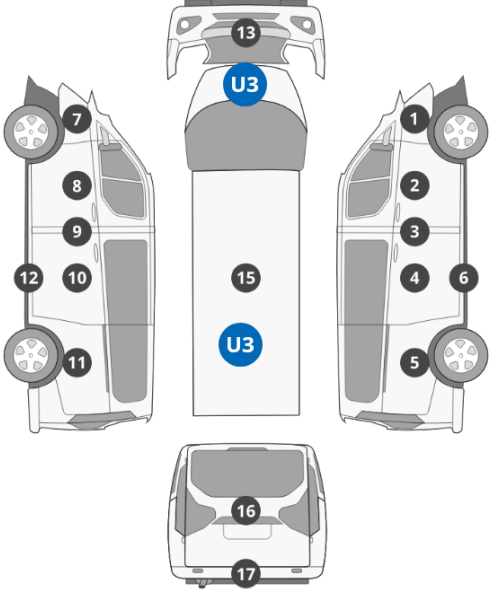
<b>Inspector Notes</b>
<p>Cluster of dents at Hood and roof</p>
