## General Information

| Make | Toyota | Model | Hiace |

## Body / Panel Condition

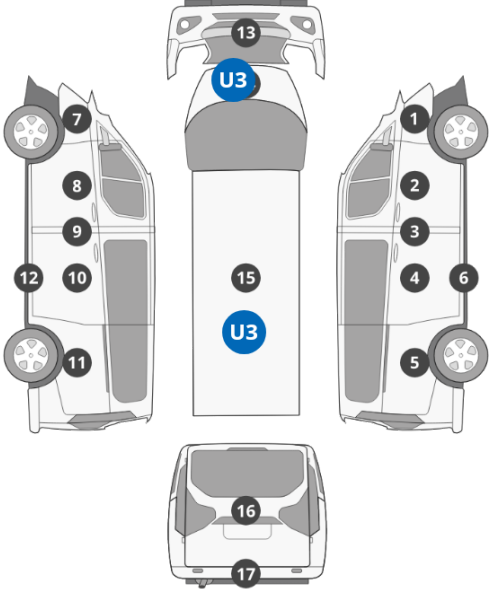
| Interior Evaluation : <b>A</b> | Exterior Evaluation : <b>B</b> |
| <b>Remarks</b><br>Defects not found | <b>Remarks</b><br>Bonnet, Headlight - Dent - Medium / Roof - Dent - Medium |

cluster of dents on roof and hood.
